## Investigation Report 149/08

**Serious marine casualty**

**Forward tug WILHELMINE  
broaching to in front of  
MV PAVEL KORCHAGIN  
on 4 April 2008  
in the Port of Hamburg**

15 April 2009

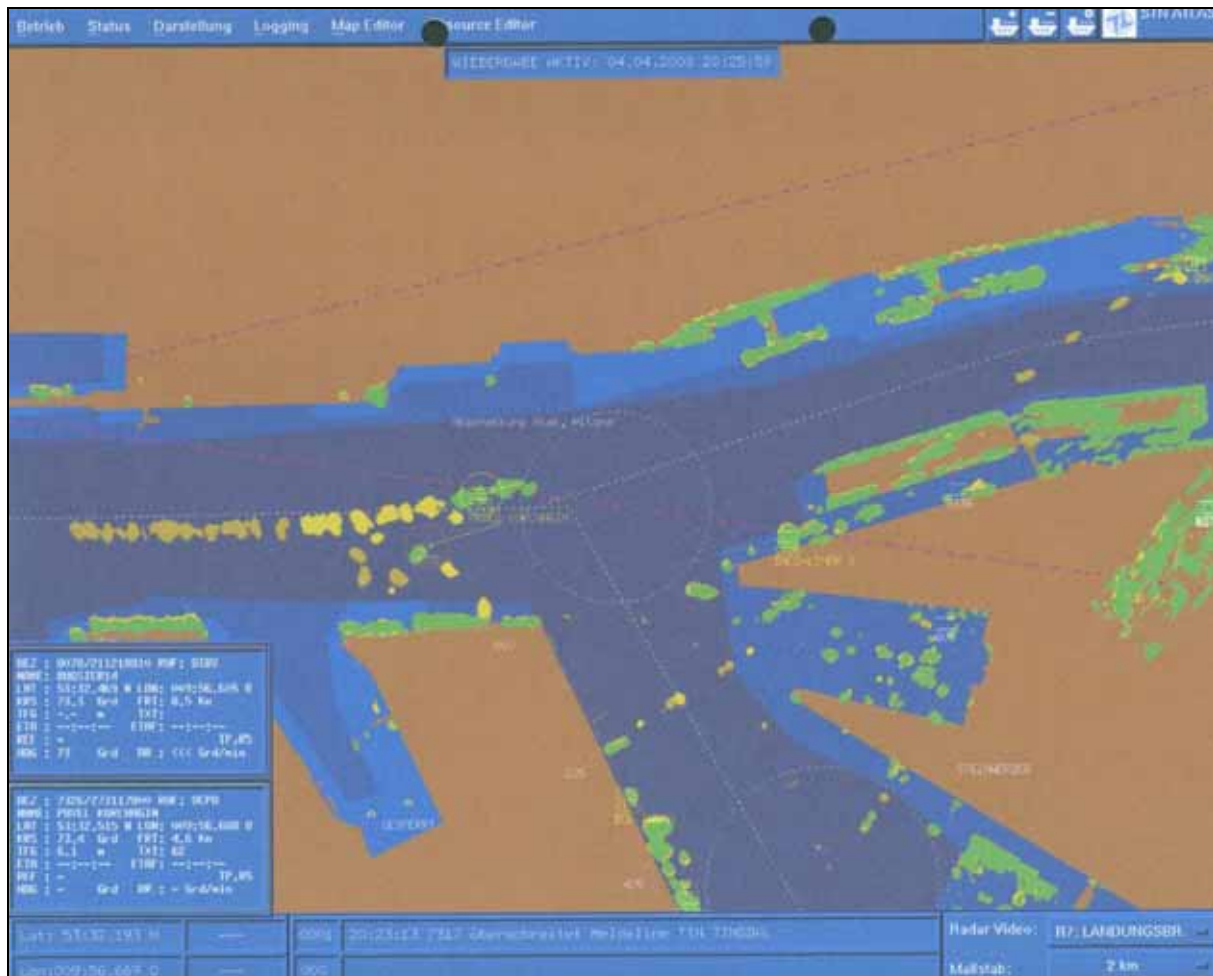
Figure 5: Vessel Traffic Service 2025:59

At 2026, as the tripping line of the hawser was being hauled in, the WILHELMINE broached to in front of the PAVEL KORCHAGIN and was hit by her bow slightly aft of amidships on port side despite previous endeavours to come off by applying "Full Ahead" and counter steering. The tug was listing to starboard and the deck had been flooded. Then the tug came off, righted herself and ended up on the port side of the seagoing vessel. On the bridge, two people were knocked to the floor. At the stern of the vessel, one person fell outboard but was able to hold on to a tire fender.

The current conditions are modelled by the Hamburg Port Authority's Department of Current Development and Hydrology. The results were verified against the real data of the measuring device at Teufelsbrück jetty. According to the results, the current at the scene of the accident was moving 0.5 m/s westwards with an outgoing tide, i.e. at the take-up of the hawser line, the PAVEL KORCHAGIN had a speed through water of 9.2 kn, if 8.2 kn is determined as the speed over ground (see Fig. 5 Vessel Traffic Service, and the Appendix).

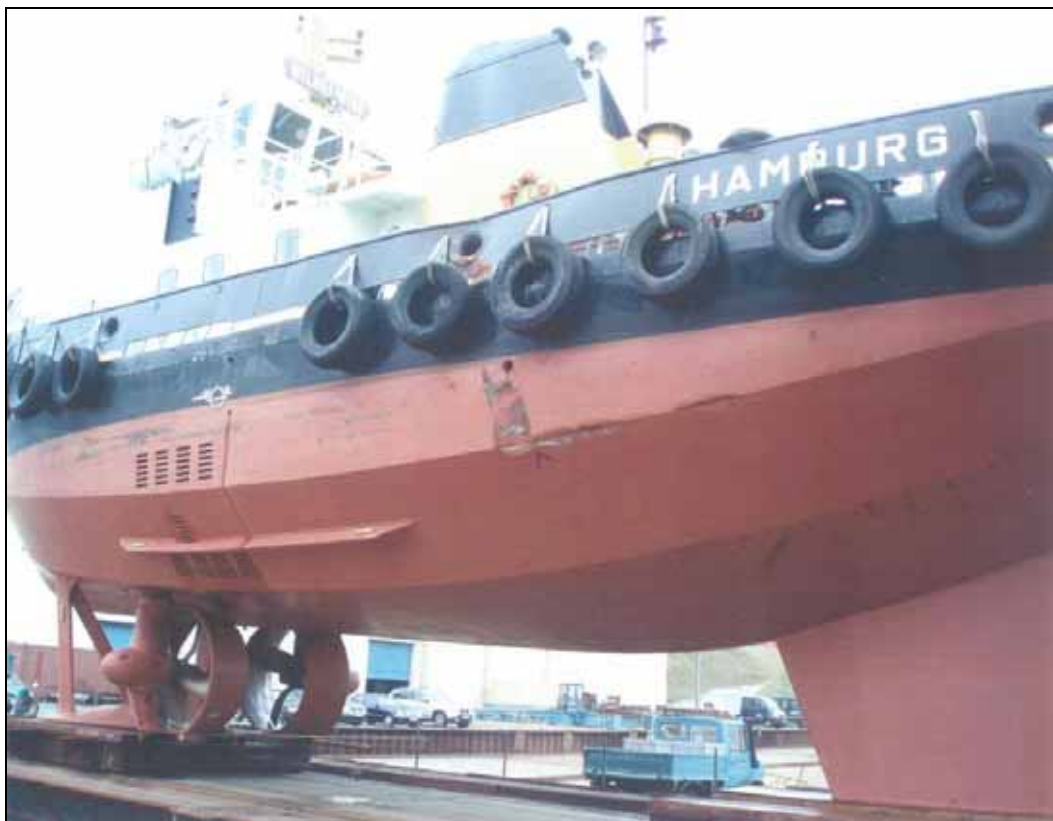
Figure 6: Underwater hull

Following the accident, the tug was moored with starboard side to the outside jetty in Neumühlen. During the mooring manoeuvre, a lowered line was probably caught by the port Schottel drive during an astern manoeuvre. Several tire fenders lay on the starboard stern deck. The floor was wet in the superstructure. Hoses and pumps lay in the alleyways. There were no leakages in the engine room and underwater hull (see Fig. 6). The port bulwark on the main deck at the stern was dented (see Fig. 7). The bulkheads 2.5 m from the forward ballast water tank were dented and frames 18 and 21 were deformed. The tug had obtained permission from the GL surveyor to sail to Rendsburg for repairs. The engine systems were in full working order. A flange was loose on the heating valve station. The paint had come off the shell on the inside in some places. Water had penetrated through the port engine room ventilators.

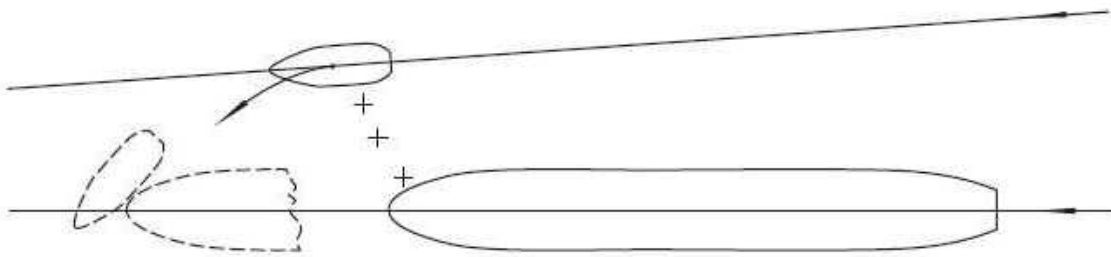
Figure 8: Overtaking situation

are sailing almost the same speed, whereby even applying hard rudder manoeuvres cannot prevent the tug from turning towards the ship. In his article "Interaction at Sea"<sup>6</sup>, E.C.B. Corlett describes situations that could arise on a forward tug which are illustrated in the following three diagrams:<sup>7</sup> In reality, it is important to note that the shallow water effect compared with deep water can increase the effective forces by up to four or five times (as a rough estimate)<sup>8</sup>. The proportions of the vessel contours correspond more or less to the accident situation. In principle, the forward tug overtakes the ship (see Fig. 8). The other way, so-called "easing off" from ahead positions, would result in the same effect. The direction of force and moment suddenly switches. The pressure conditions are indicated with +/-.

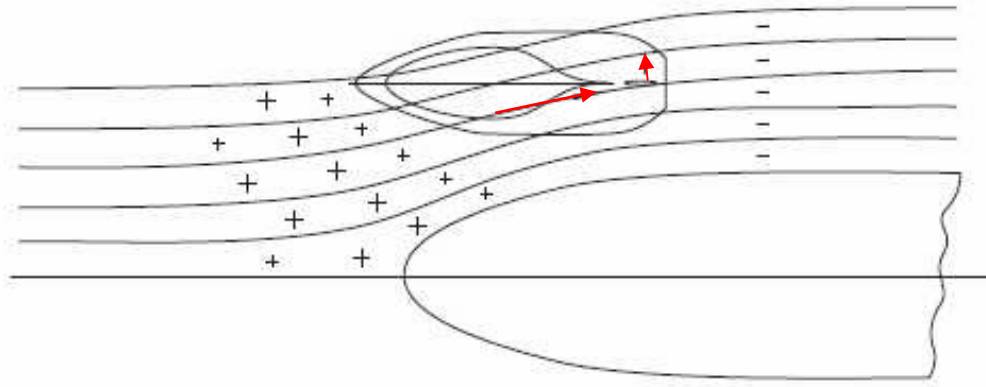
Figure 9: Bow wave

Fig. 9 indicates the angle of the current lines in relation to the tug and its skeg. The tug has to countersteer possibly 15° in order to remain parallel. On an ideal course, the WILHELMINE would have available the specified bollard pull of 30 t with an optimum position of the Schottel propeller for steering. The steering force of a rudder propeller tilted by the angle  $\delta$  against the direction of travel gives the following

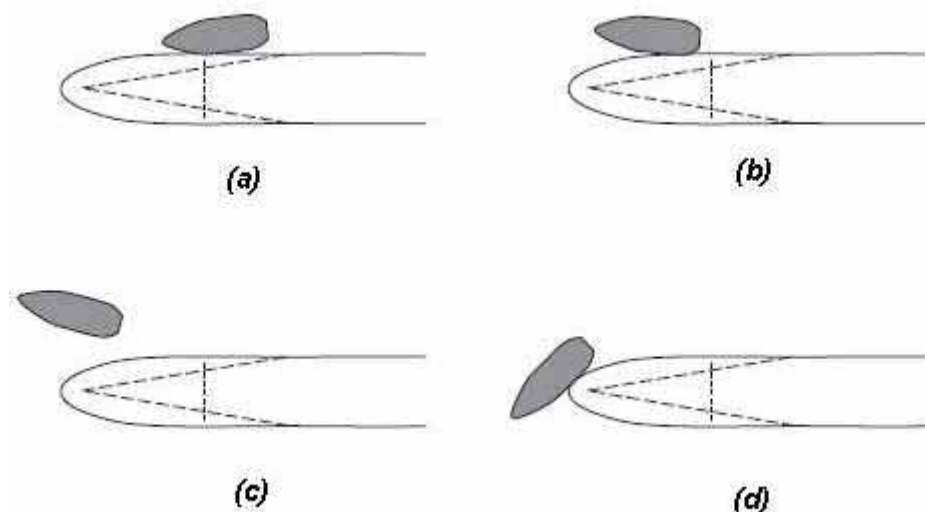
Figure 10: Course of the accident

For the take-up of the tripping line on the starboard side of the PAVEL KORCHAGIN, the tug WILHELMINE had to sail close to the front of the ship and the bow. Shortly before broaching to, at 2025:29, the speed over ground was 8.2 kn. Travelling against a current of 1 kt, both vessels had a speed through water of 9.2 kn. This speed is decisive for the calculation of the hydrodynamic longitudinal and transverse forces, as well as the yaw moments. At a maximum speed of 11.0 kn, the WILHELMINE had only little force reserves left to maintain distance (see Fig. 10a-10c). During this manoeuvre, the stern of the tug can swing unexpectedly to starboard when abeam of the ship's bow water line (see Fig. 10d) if this is not counteracted by sufficient rudder moments. The result was that, following a "Full Ahead" manoeuvre, the WILHELMINE broached to across the bow of the PAVEL KORCHAGIN. If there was any doubt, such a manoeuvre should have been aborted, especially as the speed was relatively high at the time of line take-up and the local physical effect cannot be calculated. The effective forces and moments can only be decreased by reduced speed.

The Federal Bureau of Maritime Casualty Investigation recommends the masters of assistance tugs for seagoing vessels and port pilots to establish towing connections only on minimum possible speed and intensify communication as regards when, where and on which speed towing connections should be established.
