**REPORT: M/V “MIRACH” R- 027-2011- DIAM**

**MIRACH”, IMO NO. 8116881**

**GROUNDING ON CROCODILE ROCK**

**OFF CAPE COMORIN, INDIA**

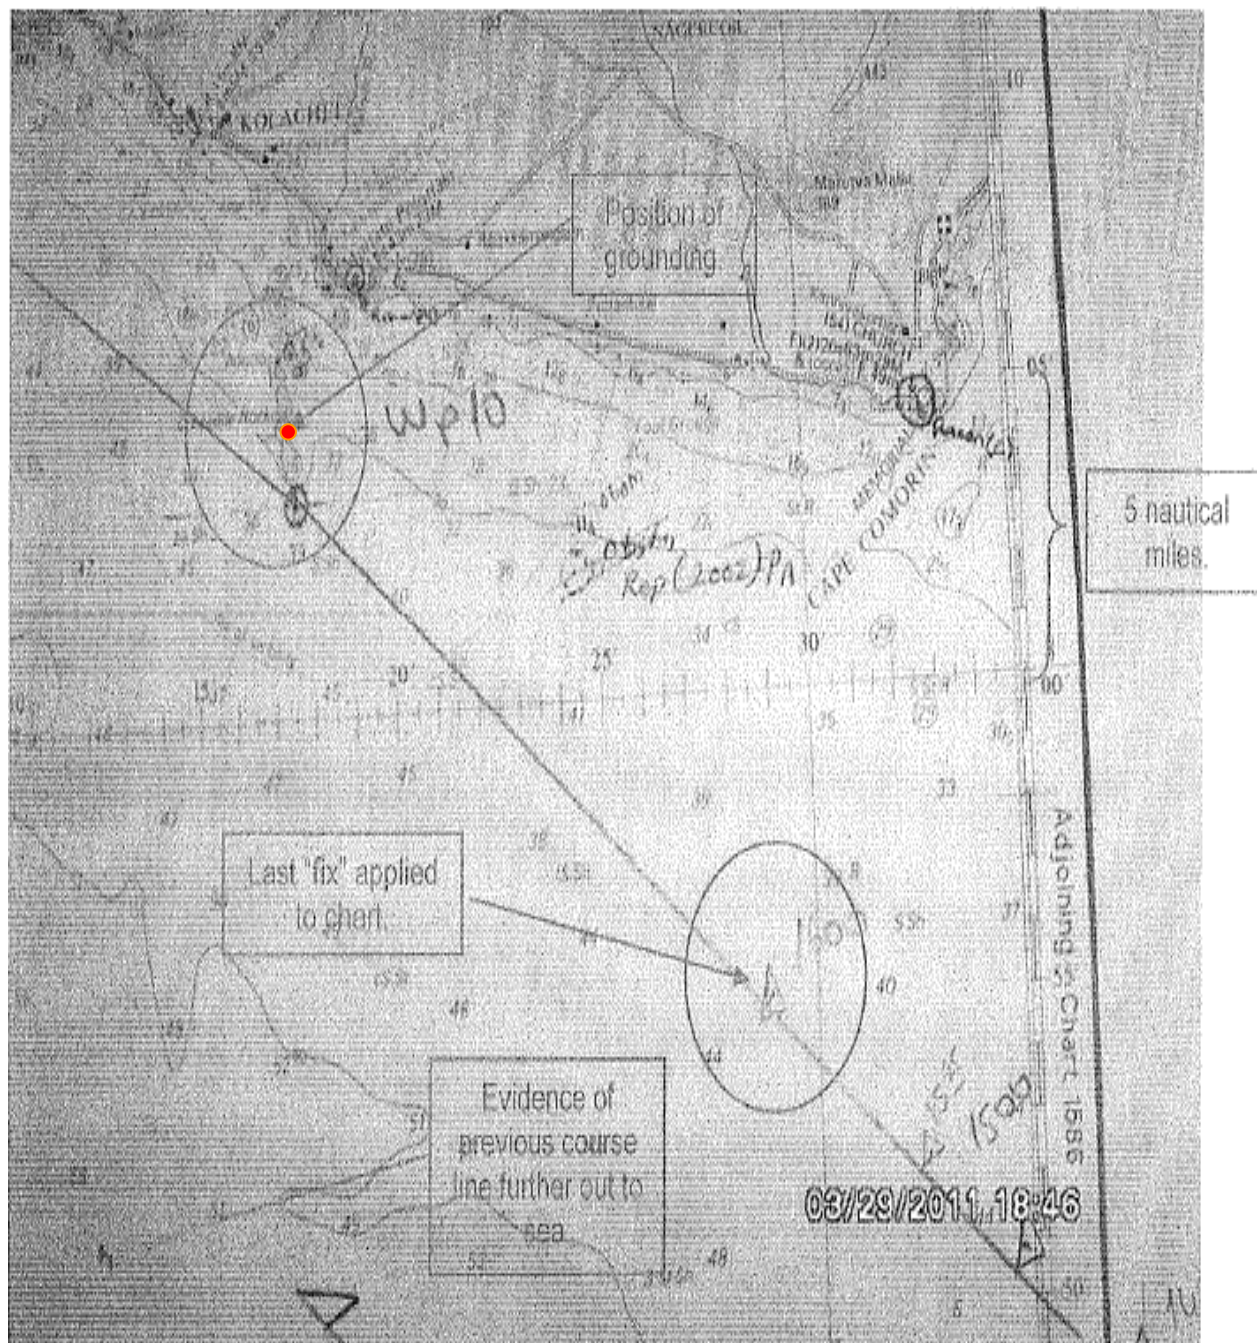
Photo no.3: BA Chart 1566, Vessel's last position plotted at 1600 hours

Ship's positions were plotted on navigation chart from 1600 hrs onwards for next two hours neither by Chief Officer nor by his reliever, Third officer due to distraction and loose presence of mind. Master's instruction was over looked to steer away from shore.

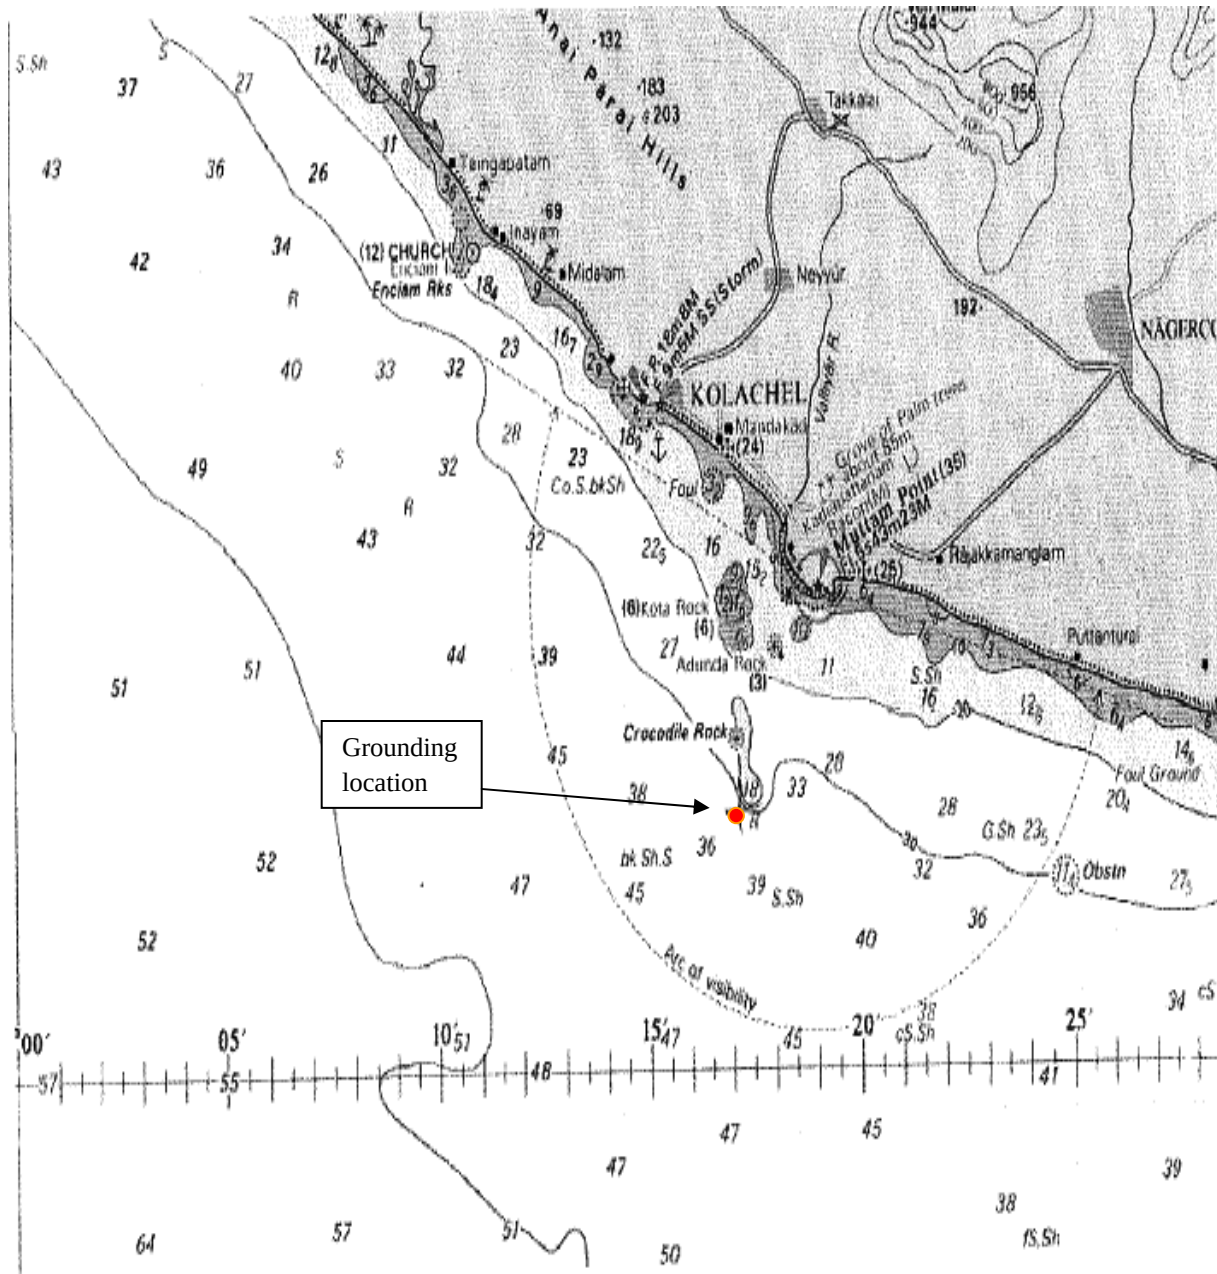
Photo no.4: BA Chart 1566, Location of grounding

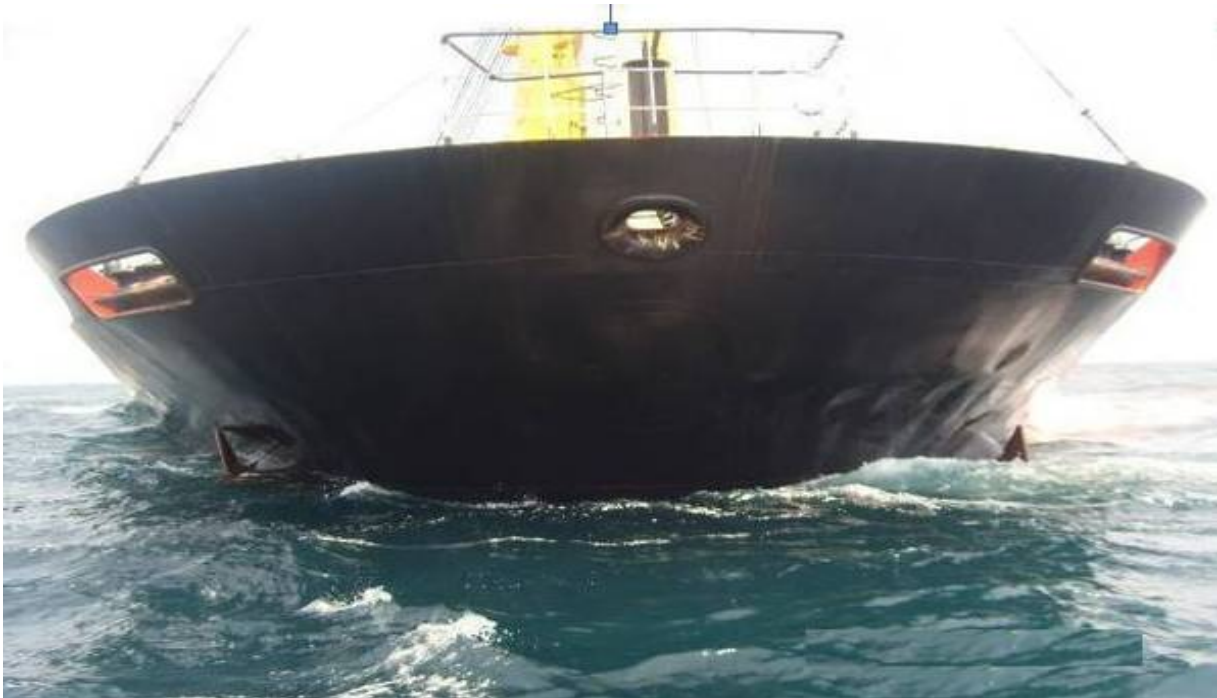
**Photo no.5: 3 April 2011, Bow view**

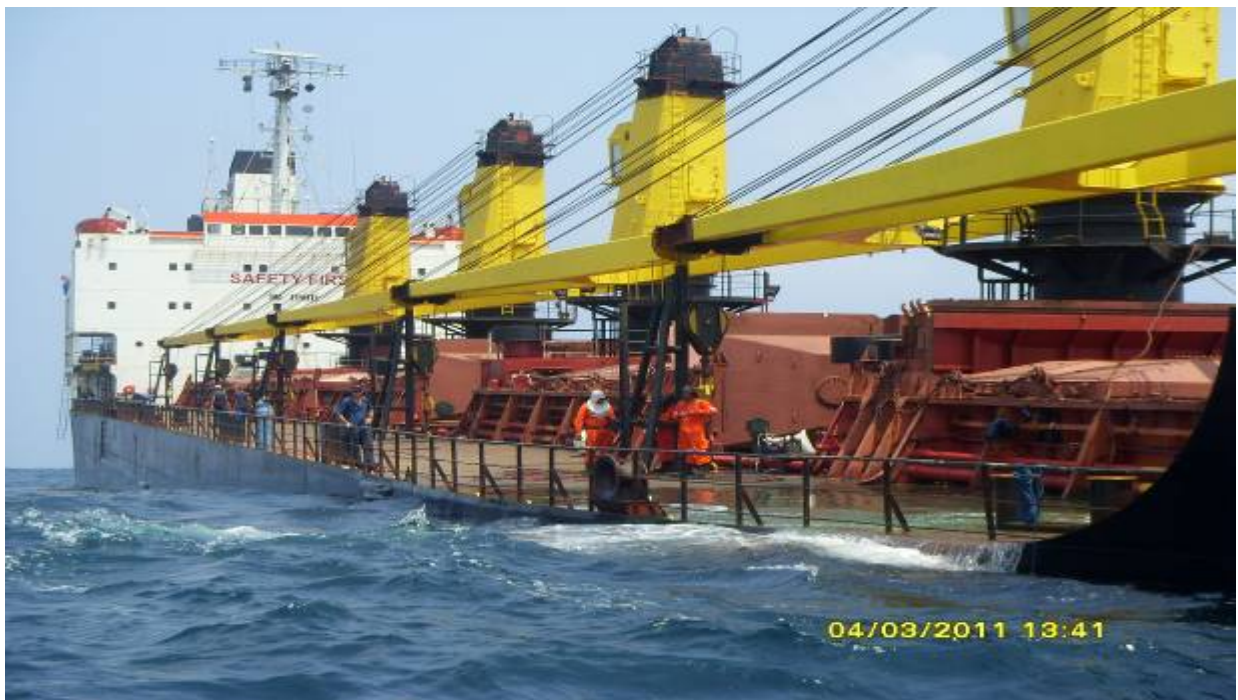
The damages to ship were not visible as all damages were on the hull below water. Due to direct impact, fore peak tank and no.1 DB port and starboard ballast tanks were ruptured and flooded to sea level. No.1 cargo hold was also having ingress of water but damage location could not be verified as hatch cover was closed with cargo in hold, the damage were expected from forward collision bulkhead and/or ship side plates.

**Photo no.6: 3 April 2011, Cargo hold 1, fore peak tank and 1DB port and starboard flooded**

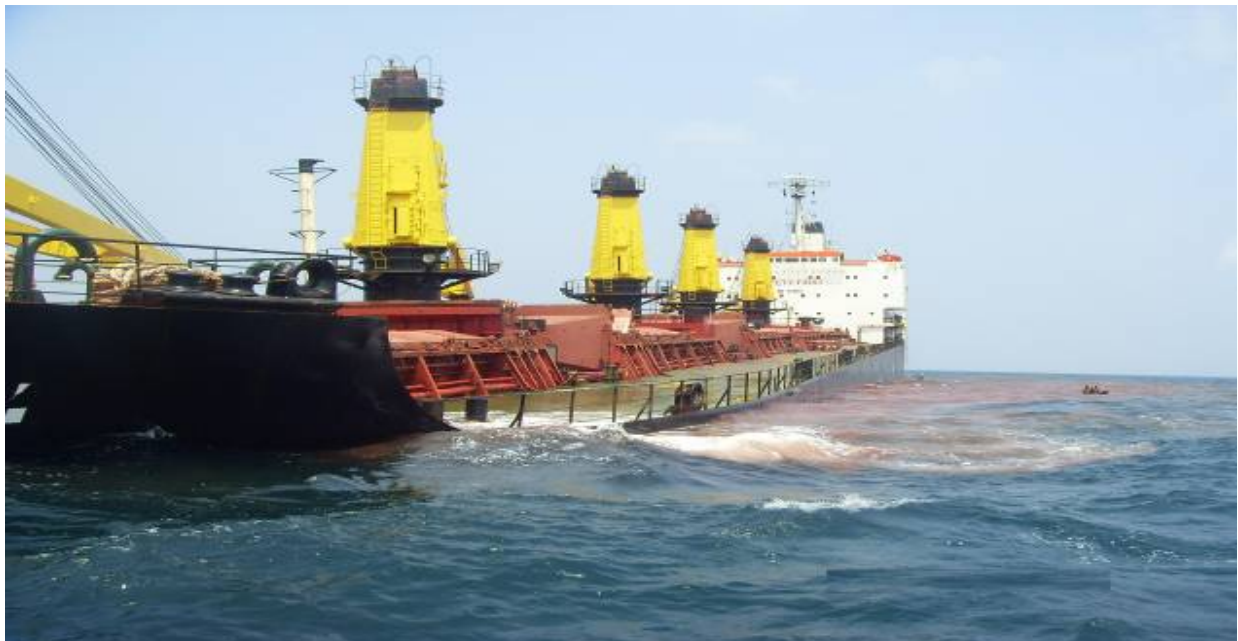
**Photo no.7: 3 April 2011. Seas shipping on forward main deck**

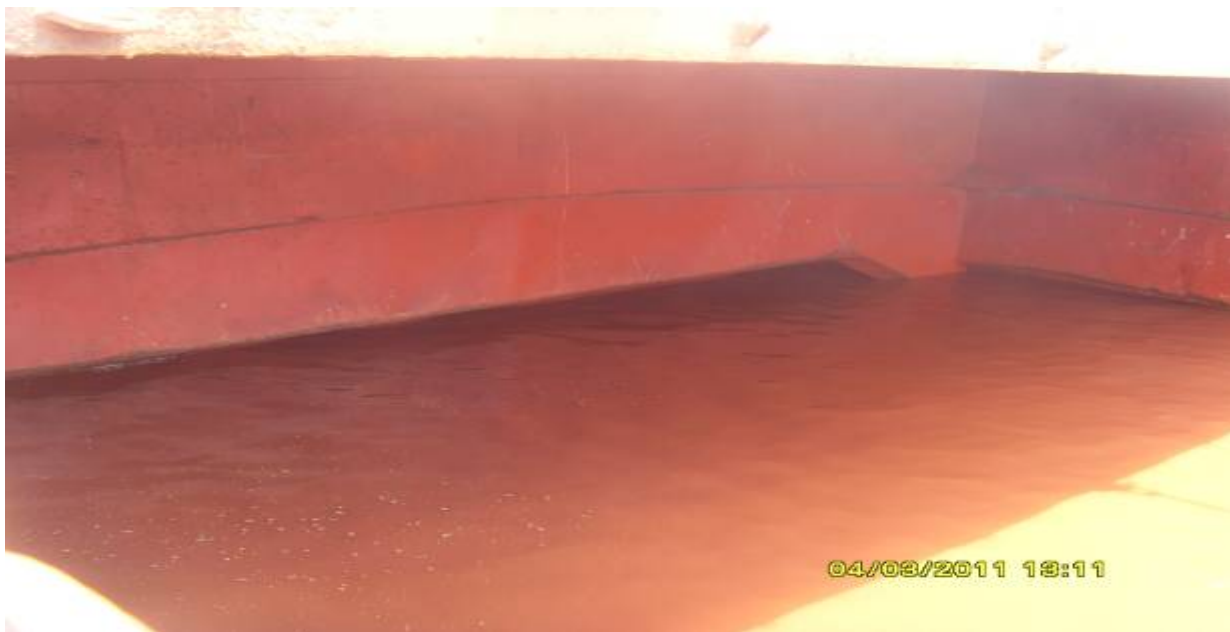
**Photo no.8: 3 April 2011, flooded cargo hold no.1**

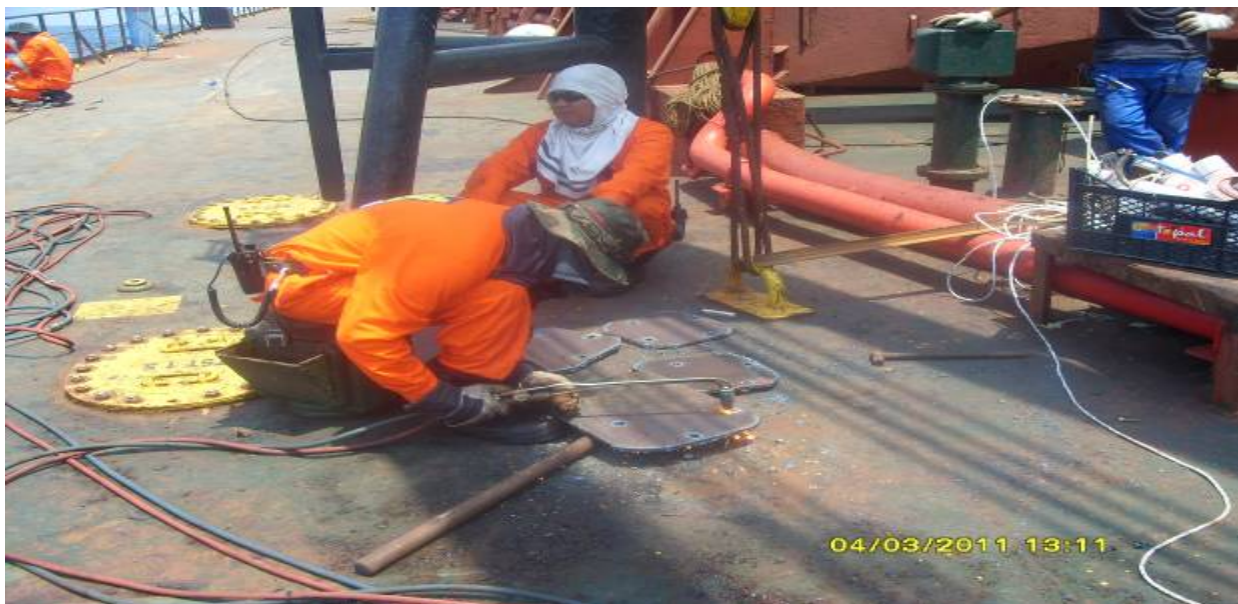
**Photo no.9: 3 April 2011, salvage team taking preventive measures against flooding**

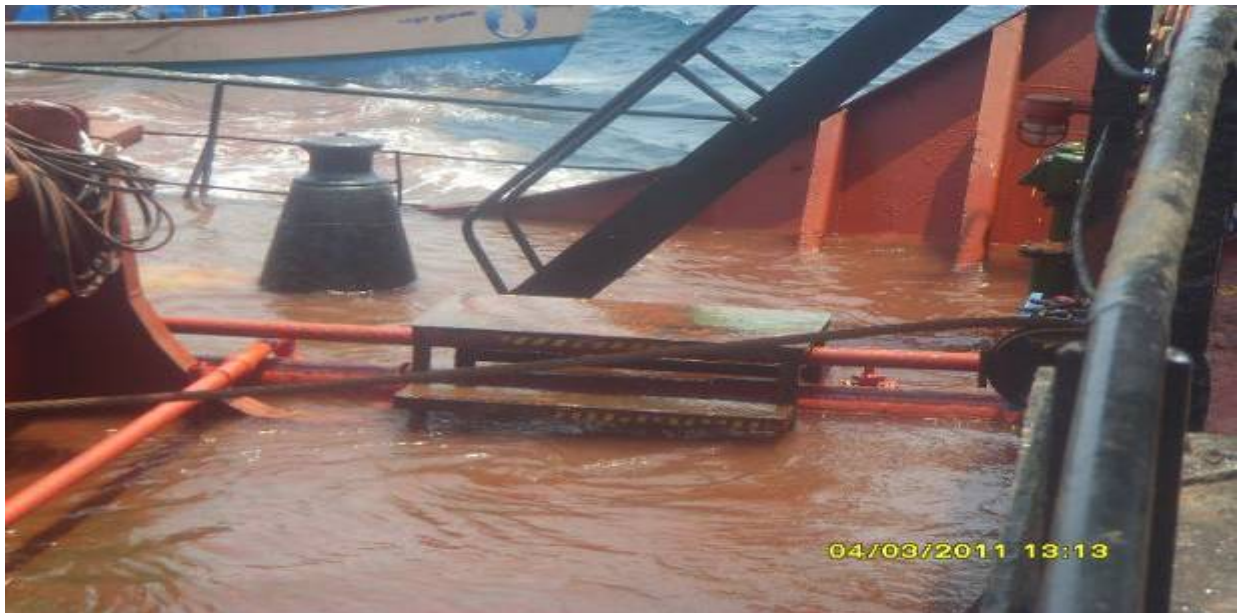
**Photo no.10: Shipping seas on main deck, forward of no.1 cargo hold**

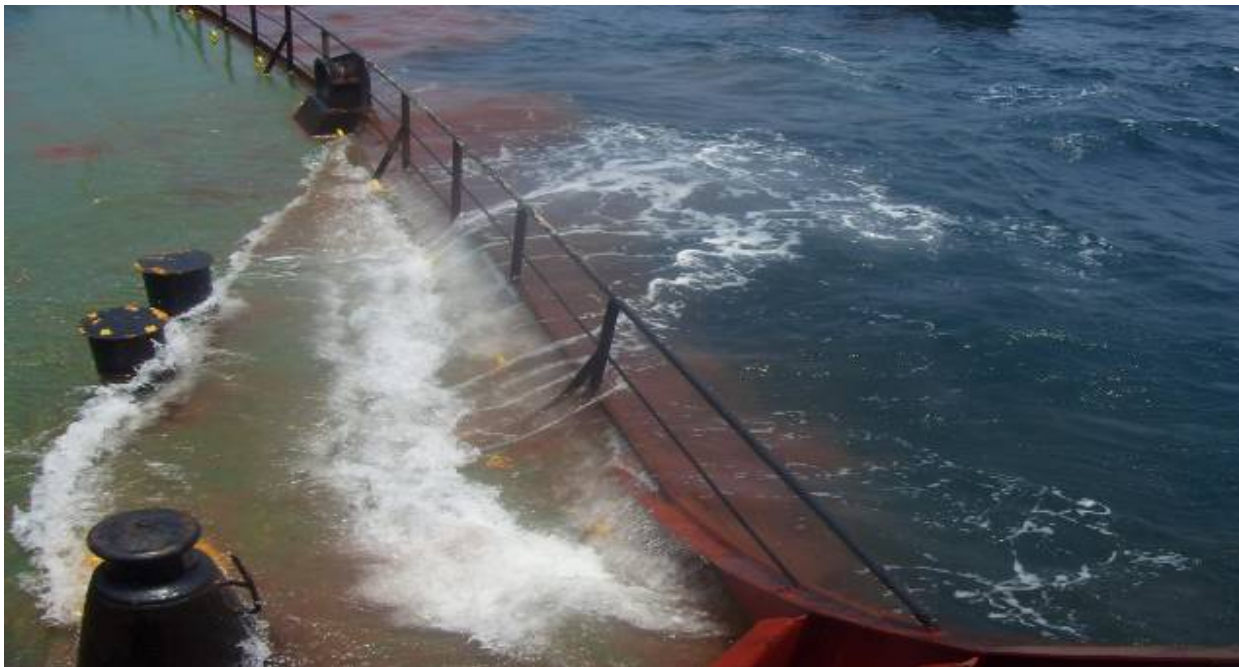
**Photo no.11: 3 April, Sea water coming on port side forward main deck**

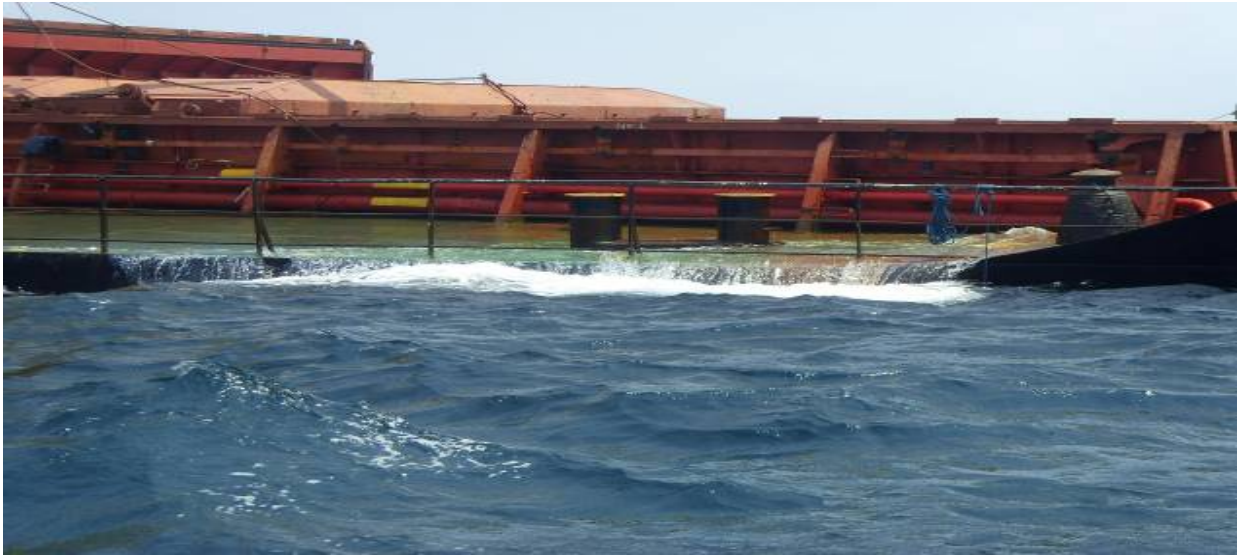
**Photo no.12: 03 April, Sea water coming on starboard side forward main deck**

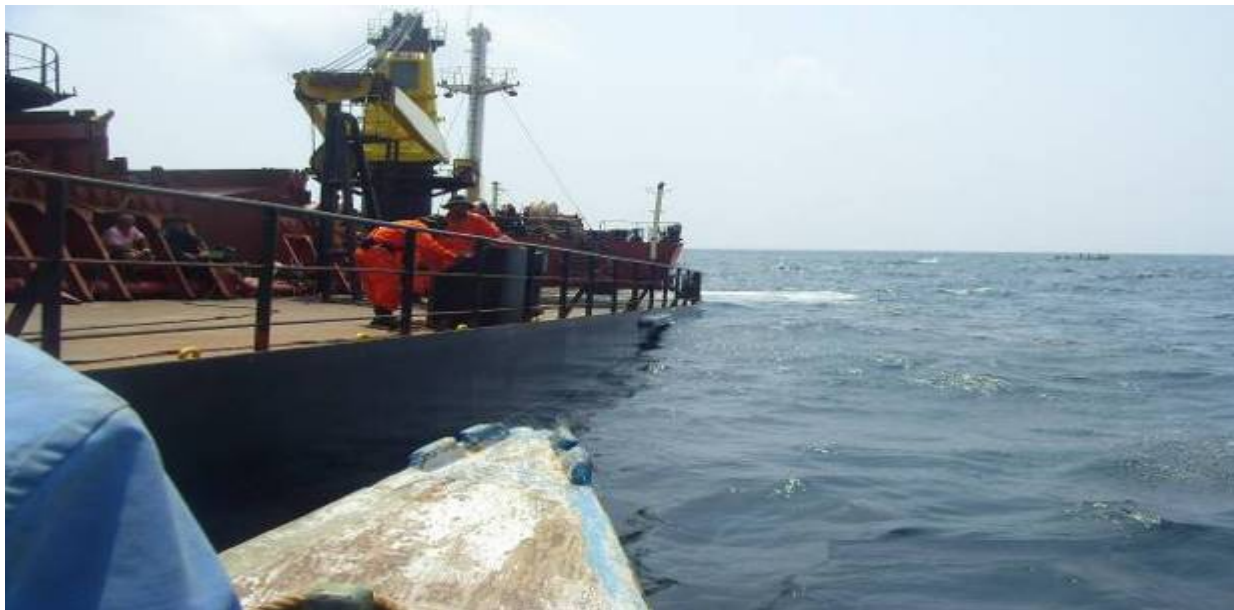
**Photo no.13: 03 April, Salvage tug crew on board, vessel down by head**

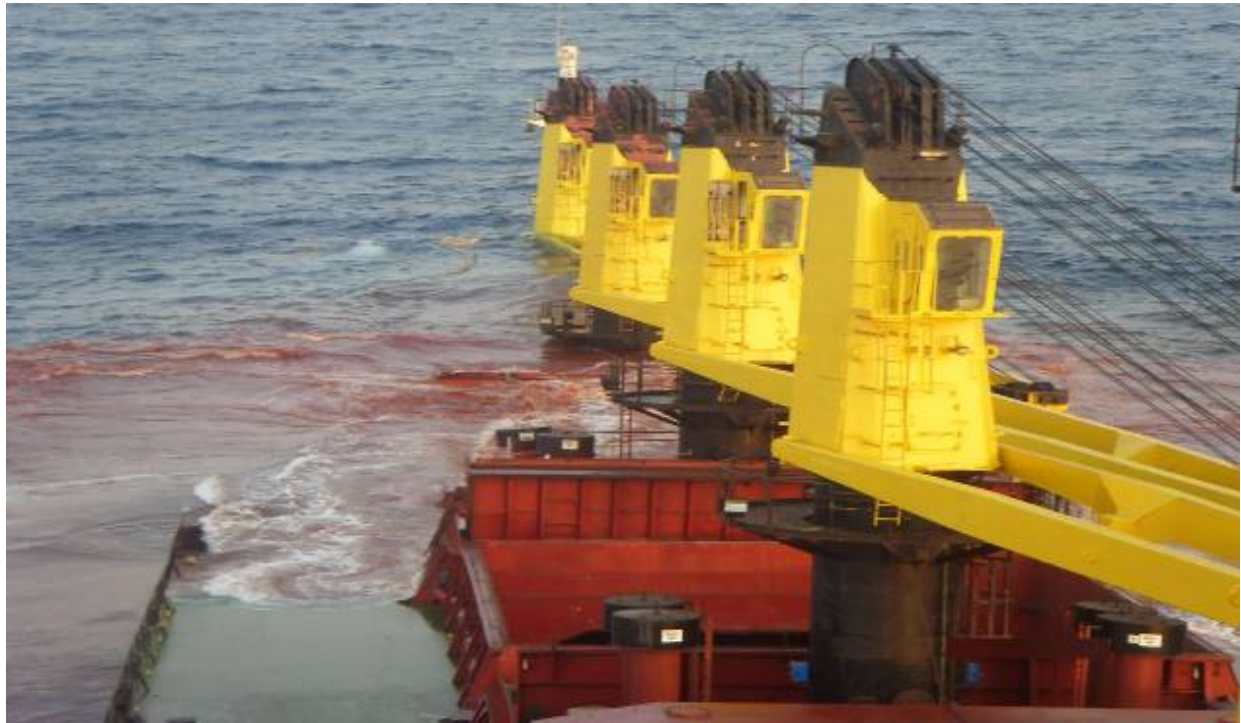
Most likely the progressive flooding caused collapse of no.1 cargo hold aft bulkhead and no.2 cargo hold was also flooded by 04 April. Due to forward tanks and cargo holds being flooded and aft areas of vessel being still afloat, maximum stress were on mid-ship section which was evident with crack on no.3 cargo hold coamings. With forward 3 holds being flooded, the progressive flooded continued in no.4 and 5 cargo holds as well in engine room/accommodation section then by 11 April the vessel completely foundered.

**Photo no.14: 04 April, before abandoning ship. Cargo hold no.2 flooded**

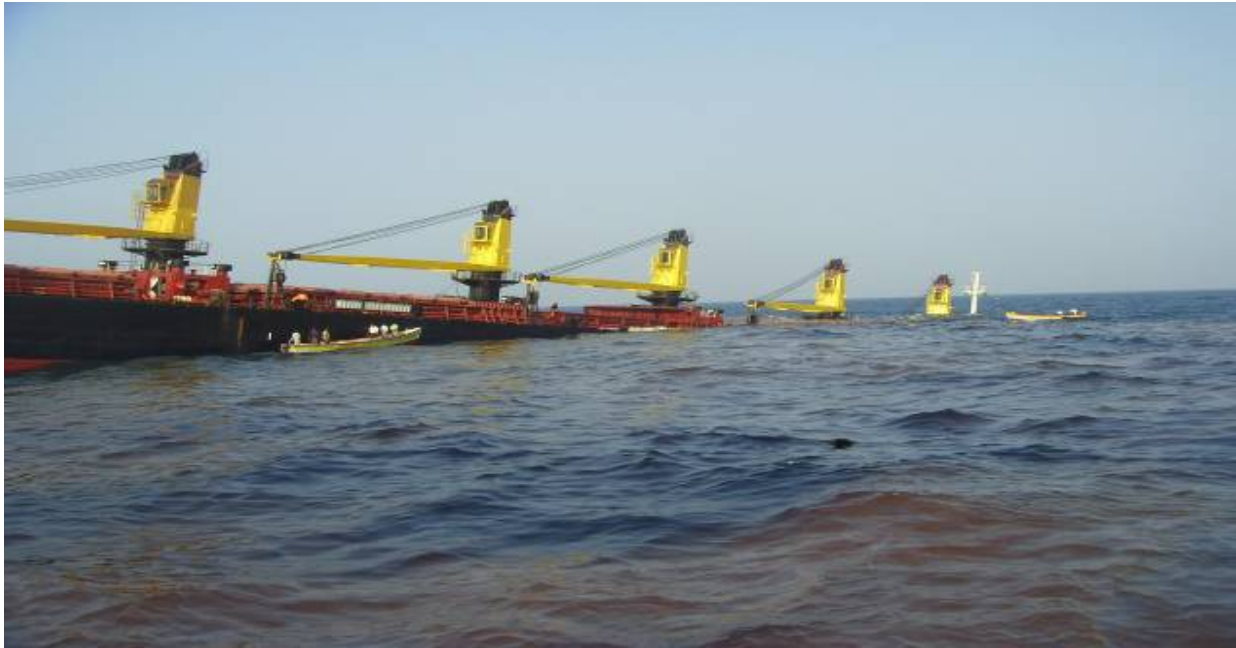
**Photo no.18: 04 April. Ship after abandonment**

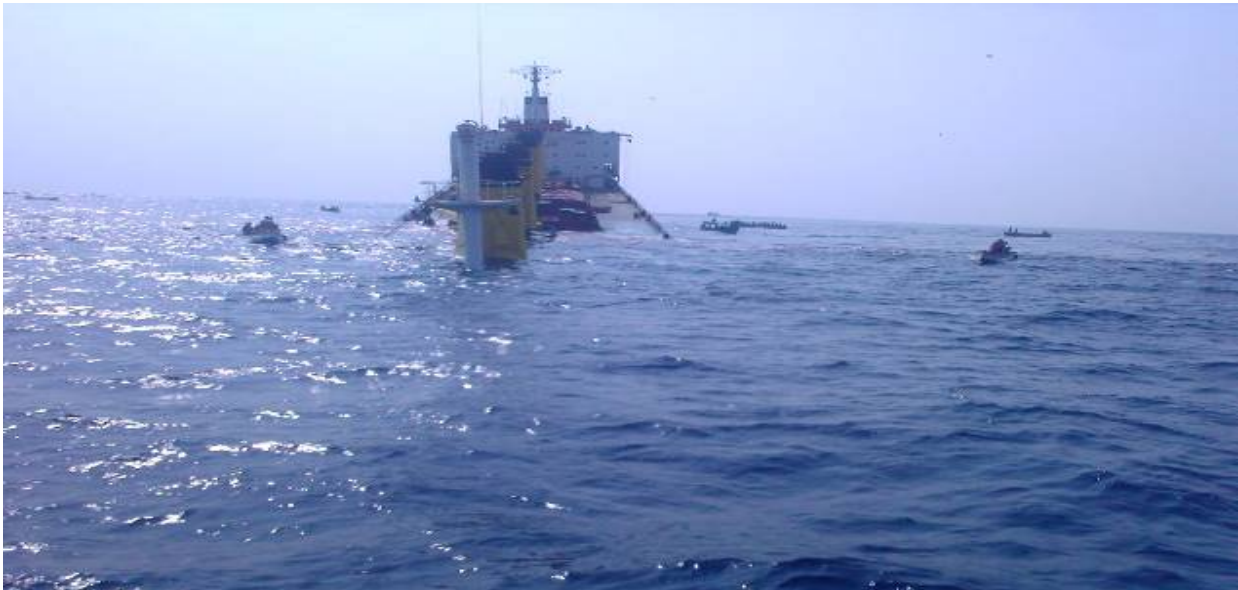
**Photo no.19: 04 April, Partially sunken ship**

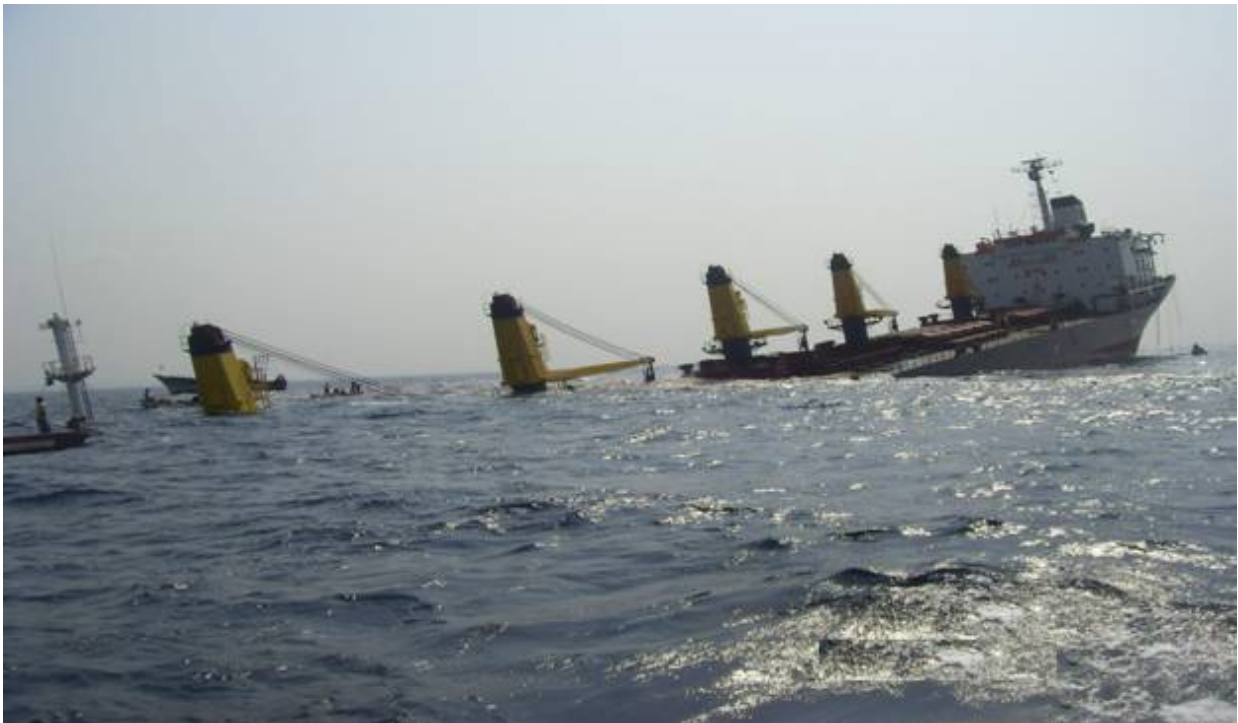
**Photo no.20: 04 April, Forward mast, no.1 and no. 2 crane mostly submerged**

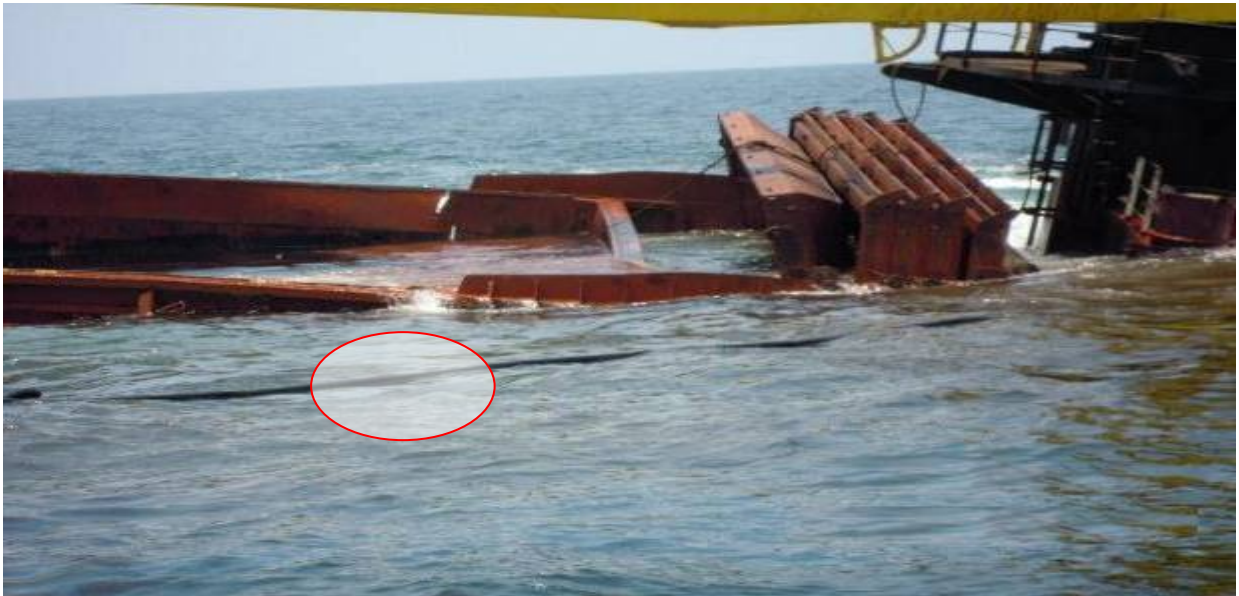
A crack was observed in way of no.3 hatch coaming indicating excessive stress in this region.

**Photo no.22: 06 April, Cargo hold no.3 flooded, Crack on port side hatch coaming of no.3**

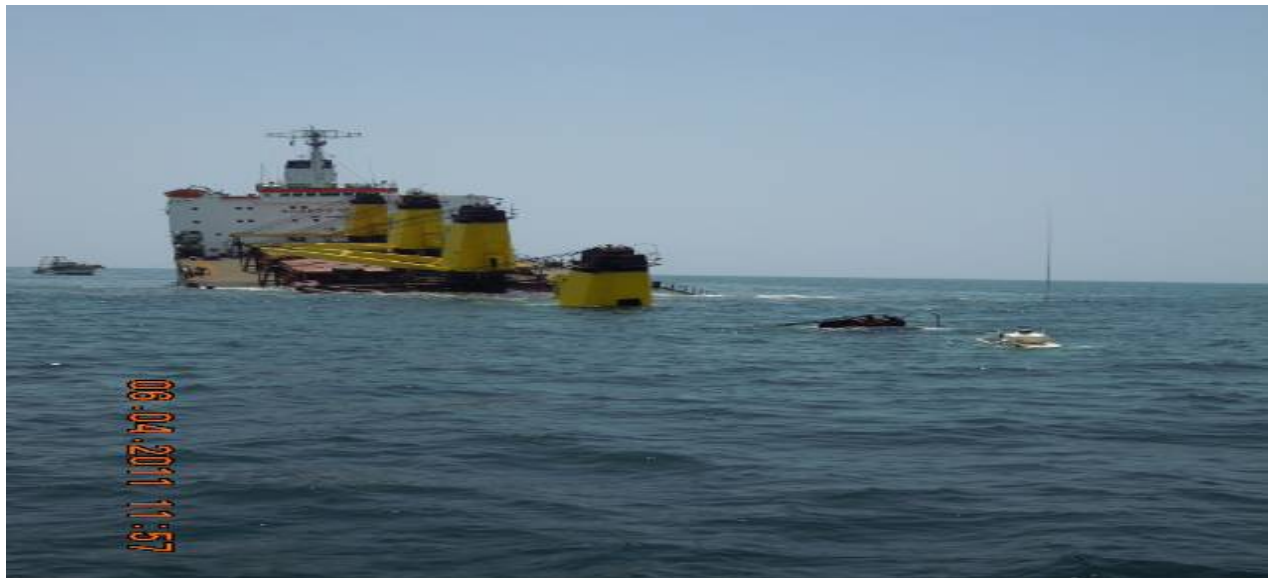
**Photo no.23: 06 April, Front view with cargo hold no.3 flooded**

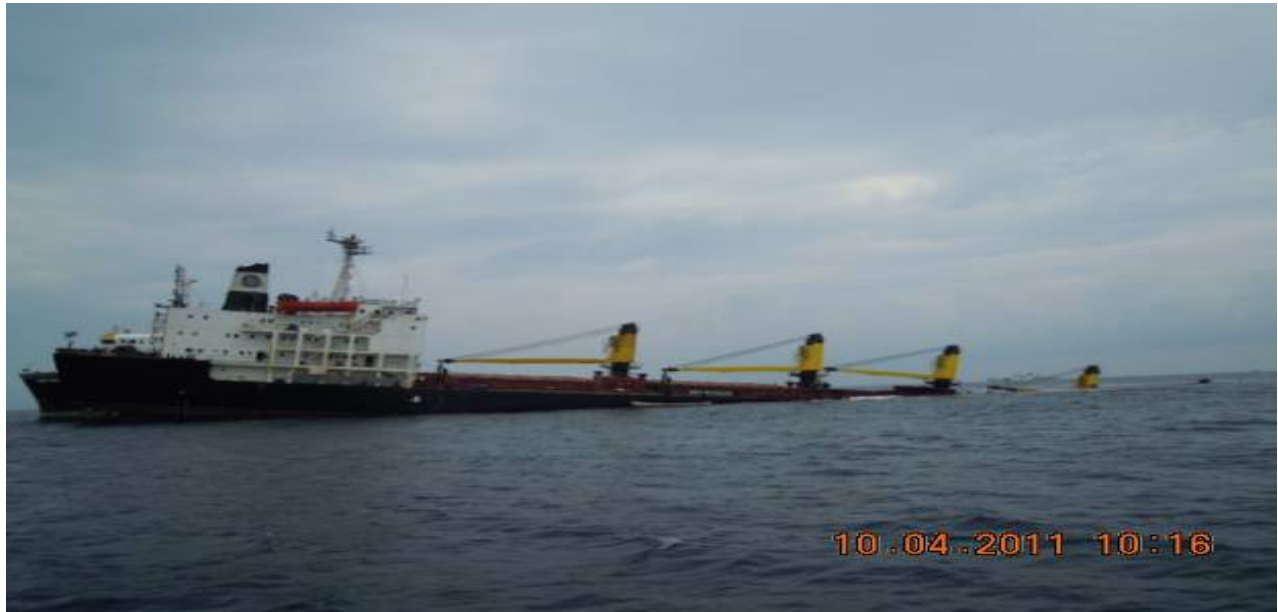
**Photo no.24: 10 April, Side view with cargo hold no.1, 2 & 3 flooded**

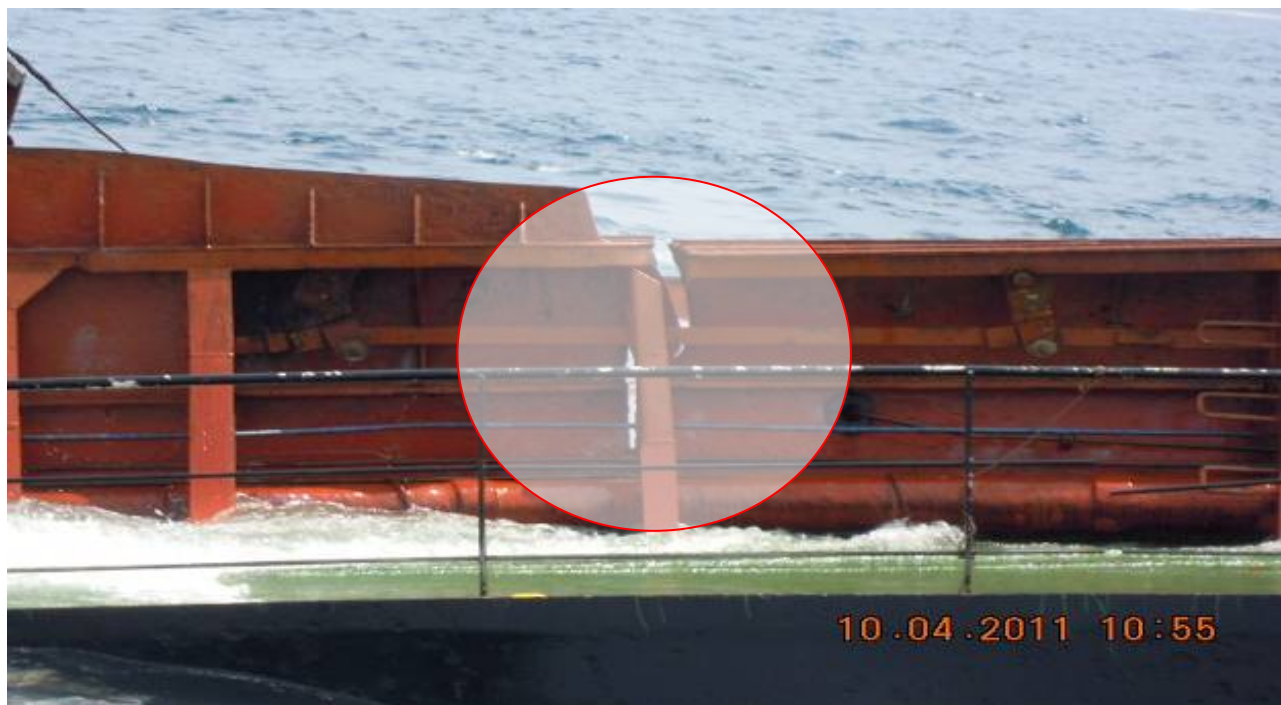
**Photo no.27:10 April, Crack was also observed on no.4hatch coaming**

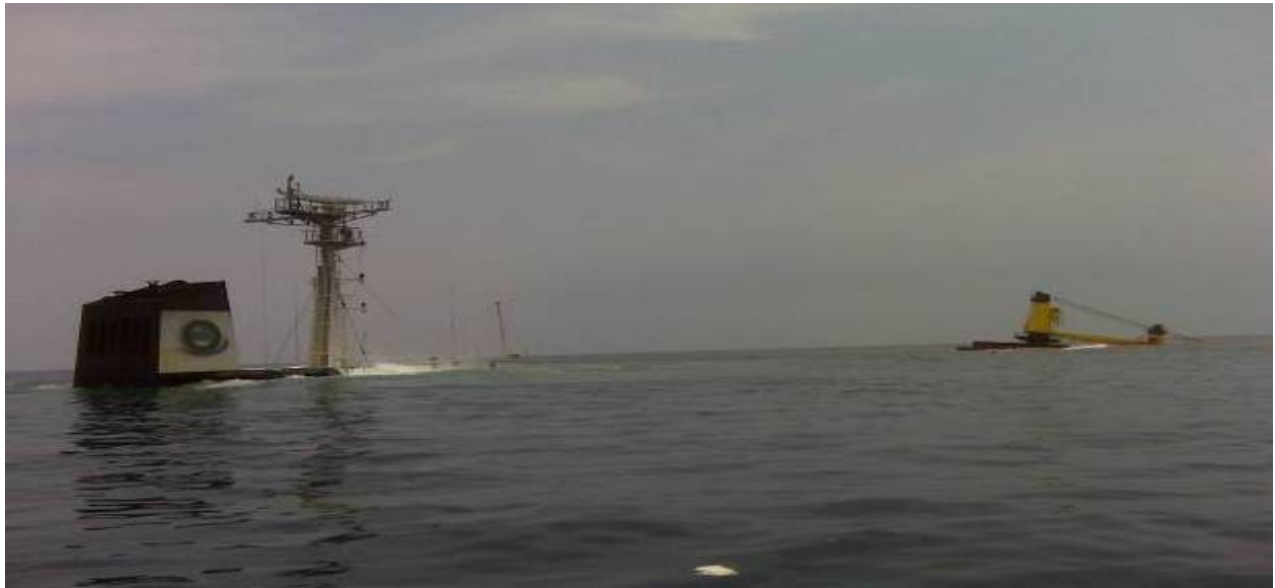
**Photo no.28: Ship foundered on 11 April 2011**

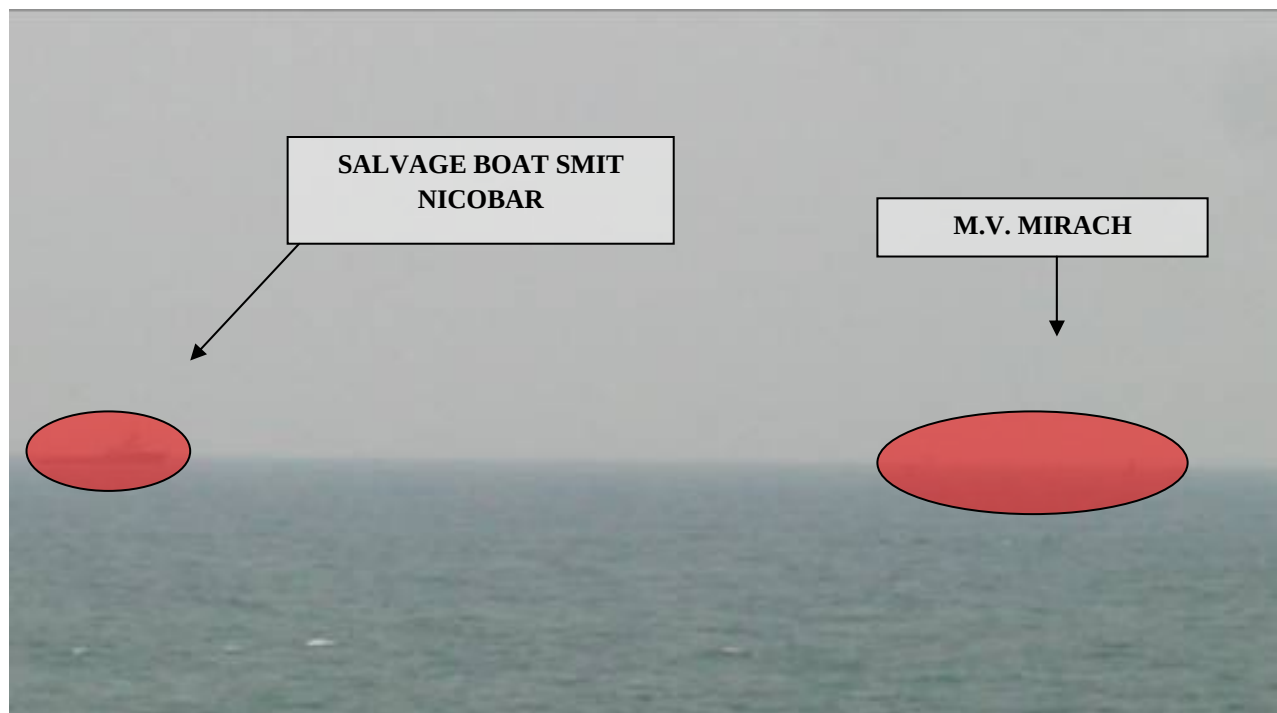
**Photo no.29: M.V. Mirach foundered & salvage tug seen stand by**
