[MSI Report 2021-001]

# Marine Safety Investigation Report on *M/V MILANO BRIDGE* - Contact with gantry cranes -

Date of Accident: 6 April 2020

Korea Maritime Safety Tribunal  
Marine Safety Investigation Team

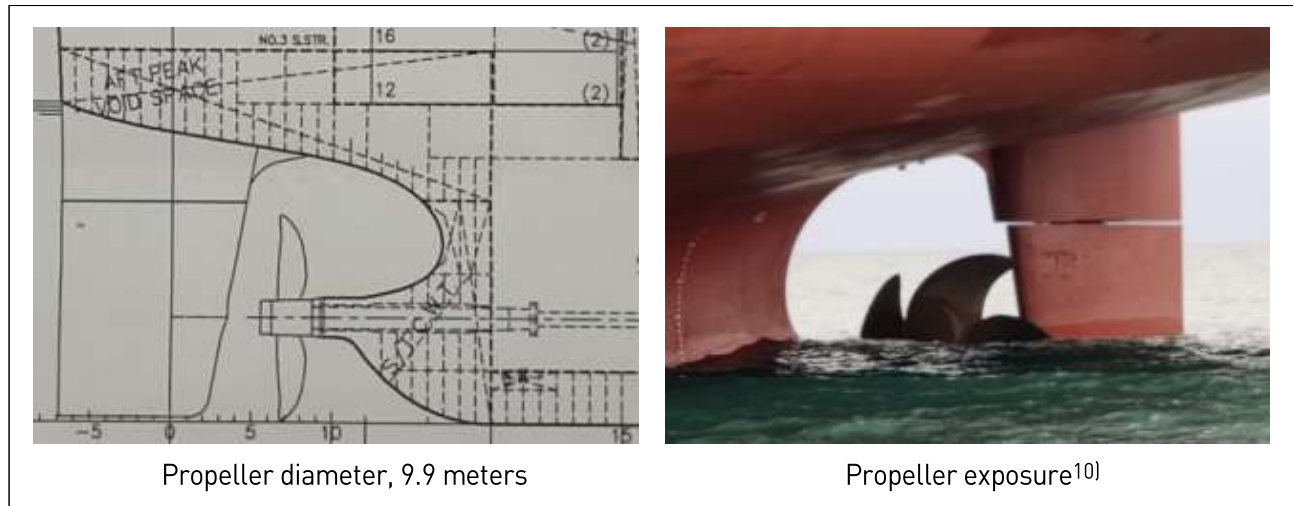
<Figure 5> Propeller exposure at the time of the accident

2.7.5 When the accident occurred, her aft draft was 6.9m, and about 3.2m, or 32% of her propeller diameter was above the waterline. The upper part of the blades and even the upper part of the rudder were out of the water.

10) This picture of the propeller conditions of *Milano Bridge* was taken right after the accident. The conditions are presumed to be the same as the ones at the time of the accident.

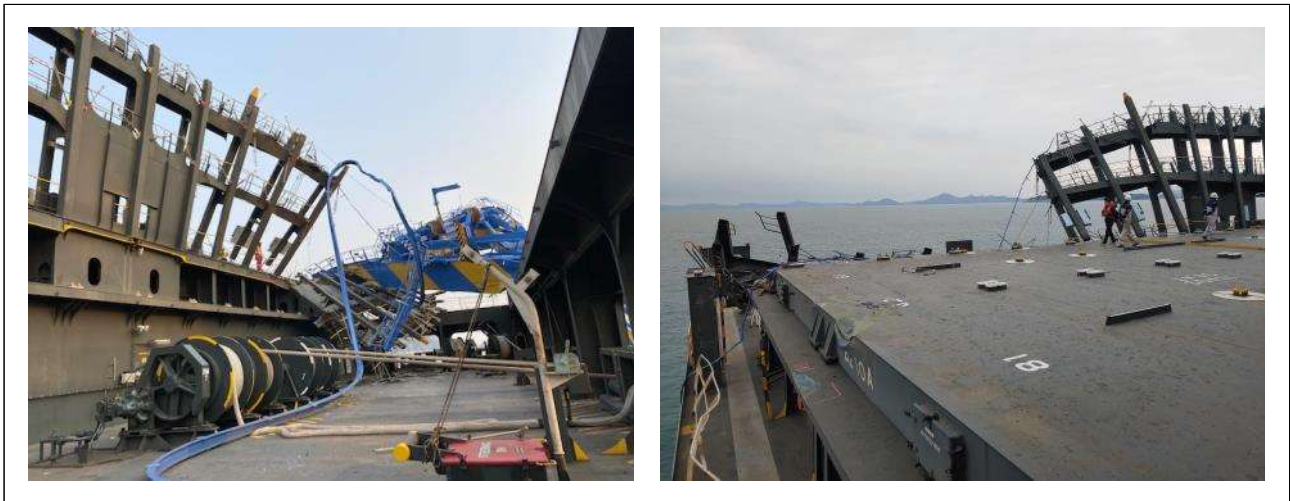
<Figure 14> Damage to the stern of *Milano Bridge*

2.13.1 After colliding with *Milano Bridge*, one gantry crane at Pier No.2 crashed and fell onto the vessel, causing damage to the port stern shell plate, aft lashing bridges and hatch coaming (Frames 10 and 11), and causing dent on part of the port side wing bridge as well. Later, *Milano Bridge* collided with the containership, M/V *Seaspan Ganges*, berthed at Pier No.7, on her way out from the pier, leaving dents<sup>18)</sup> on the

part of the port shell plate of *Milano Bridge*.

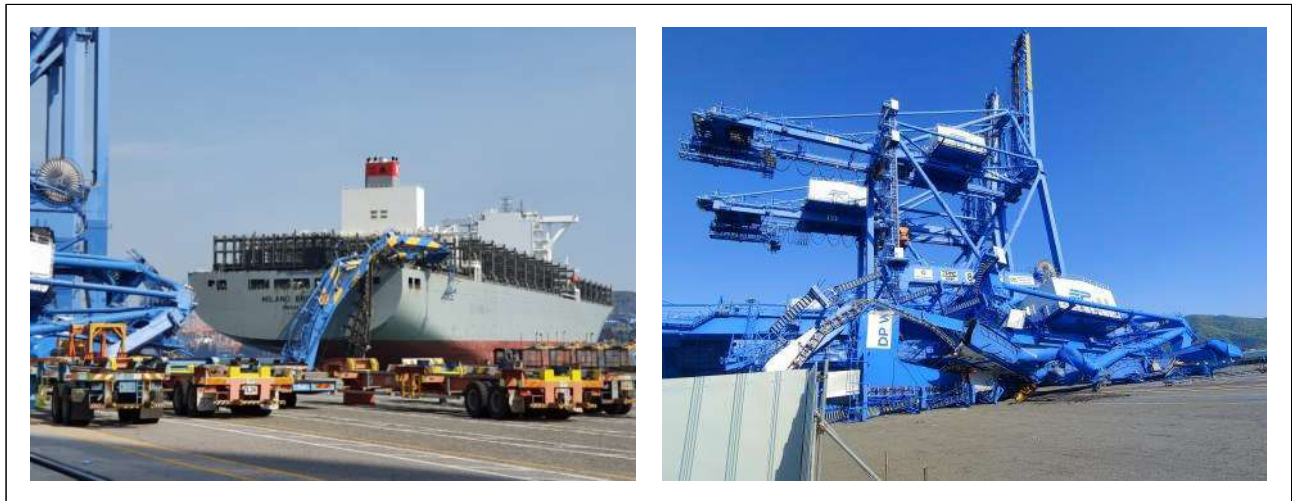
<Figure 16> Collapsed and damaged cranes

2.13.2 *Milano Bridge* contacted Gantry Cranes Nos.85, 84, 83, and 81, which were standing by for cargo operations at the pier. Nos.85 and 81 were a total loss,<sup>19)</sup> while Nos.84 and 83 sustained damage that required 9-months of repair at Jinhui Shipping Repairing & Building Factory Co., Ltd., in China. Apart from that, a rail track of

<sup>19)</sup>Gantry Crane No.85 collapsed and was destroyed after colliding with *Milano Bridge*. Nos.84 and 83 sustained partial damage. When investigating No.82, no damage was found. As for No.81, the boom of the crane collided with the wing bridge of *Milano Bridge*, and its legs collapsed, causing a total loss.

the gantry crane at Pier No.2 and asphalt sustained damage<sup>20)</sup>.

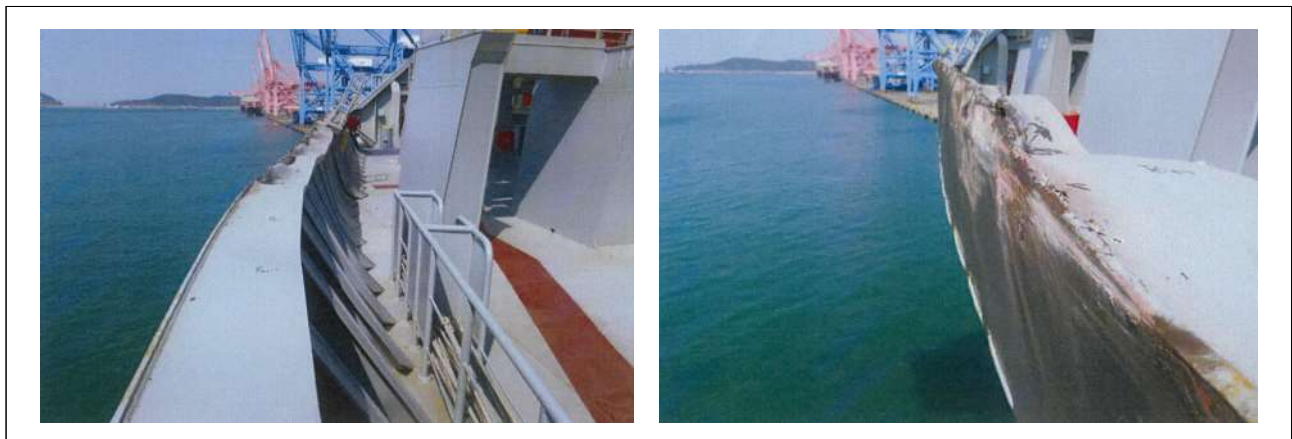
<Figure 17> Dents & damaged areas of M/V *Seaspan Ganges*

2.13.3 Also, M/V *Seaspan Ganges*, a containership docking at Berth No.7 of Pier No.2, east of the berthing place of *Milano Bridge*, sustained damage<sup>21)</sup> to the port bow shell plate (bulwark plating, etc.) and empty forepeak tank (upper bracket, etc.).

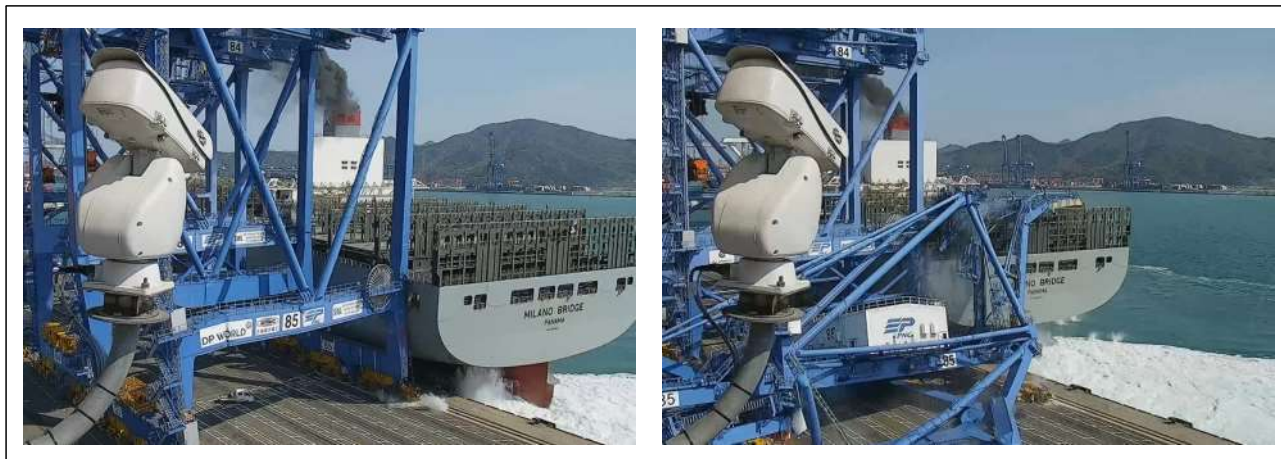
<Figure 23> Collision between *Milano Bridge* and the gantry crane (CCTV)

- 3.5.3 At around 14:38, with the bow turning to starboard, *Milano Bridge* barely passed M/V *Proteus*. However, at around 14:49, when *Milano Bridge* was on a heading of 104° at about 5.6 knots, the port bow of the vessel contacted Gantry Cranes No.84 and No.83 in succession, after a crash into a Gantry Crane No.85 at Berth No.8 of Pier No.2. As for Gantry Crane No.81, its boom, a horizontally lowered beam, made a hard contact

with the port wing bridge of *Milano Bridge*, cutting the support frame of the crane and collapsing its lower part.

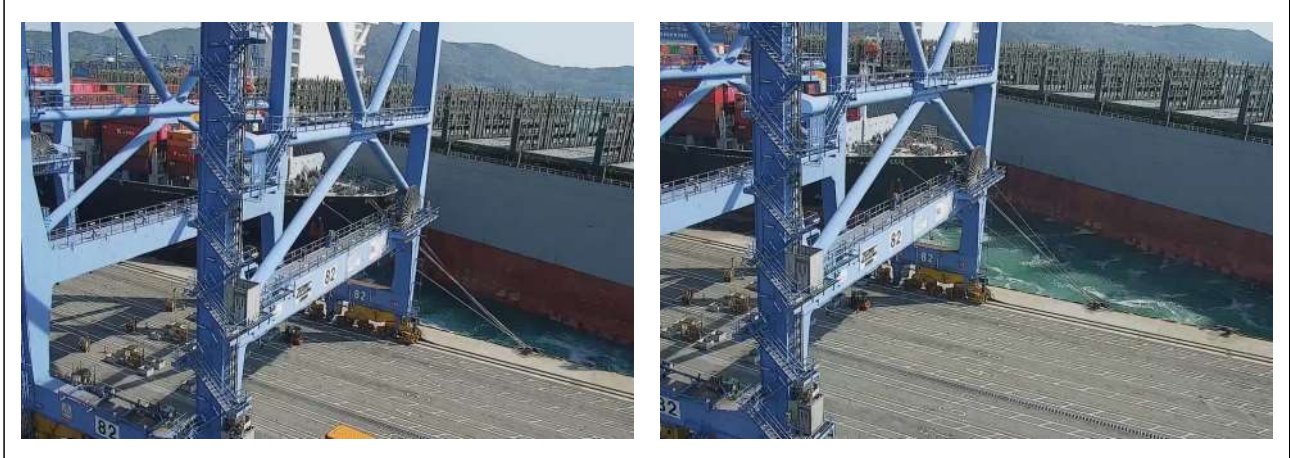
<Figure 24> Collision between *Milano Bridge* and M/V *Seaspan Ganges* (CCTV)

3.5.4 After the series of contacts with those gantry cranes, Pilot A set the main engine to crash astern in addition to dead slow astern and full astern. However, the vessel was turned to starboard and moving away from the pier at around 14:50. While doing so, the port shell plate of *Milano Bridge* brushed against the port bow of the containership, M/V

*Seaspan Ganges*, berthed on the starboard side at Berth No.7 of Pier No.2, causing dents and scratches.

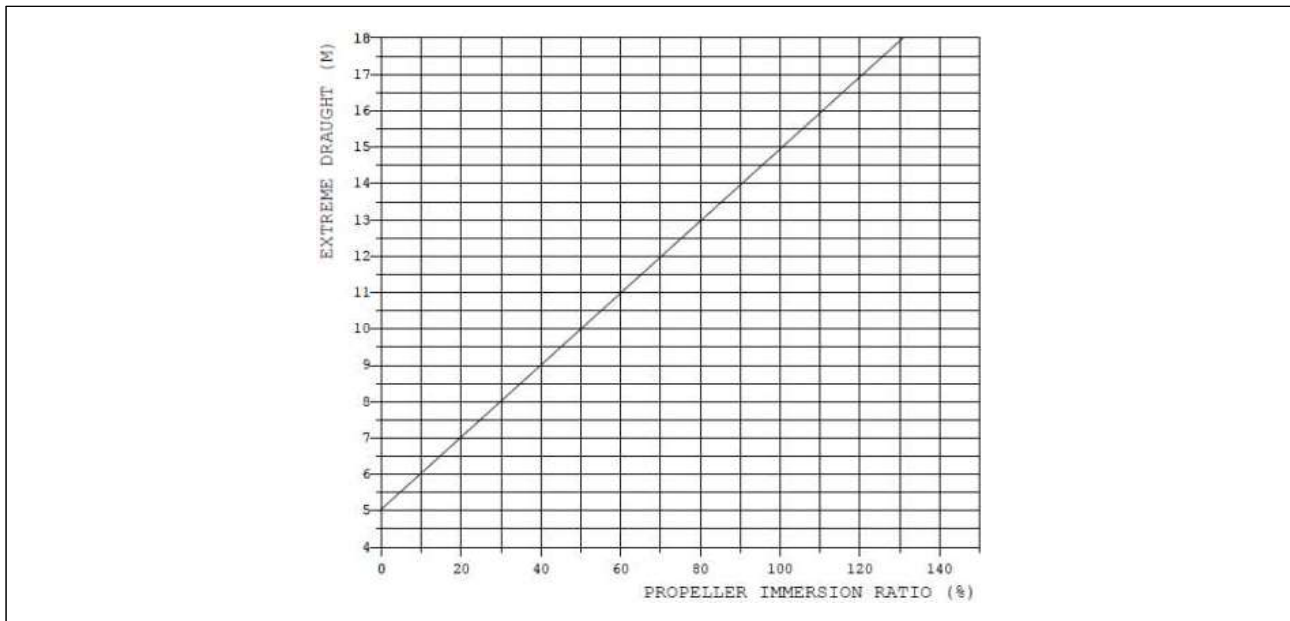
<Figure 25> Propeller Immersion Ratio Curve of *Milano Bridge*

4.3.3 Figure 25 shows the propeller immersion ratio of *Milano Bridge*, as presented in the Stability Booklet with Loading Guidance, approved by the Classification Society when building the vessel.

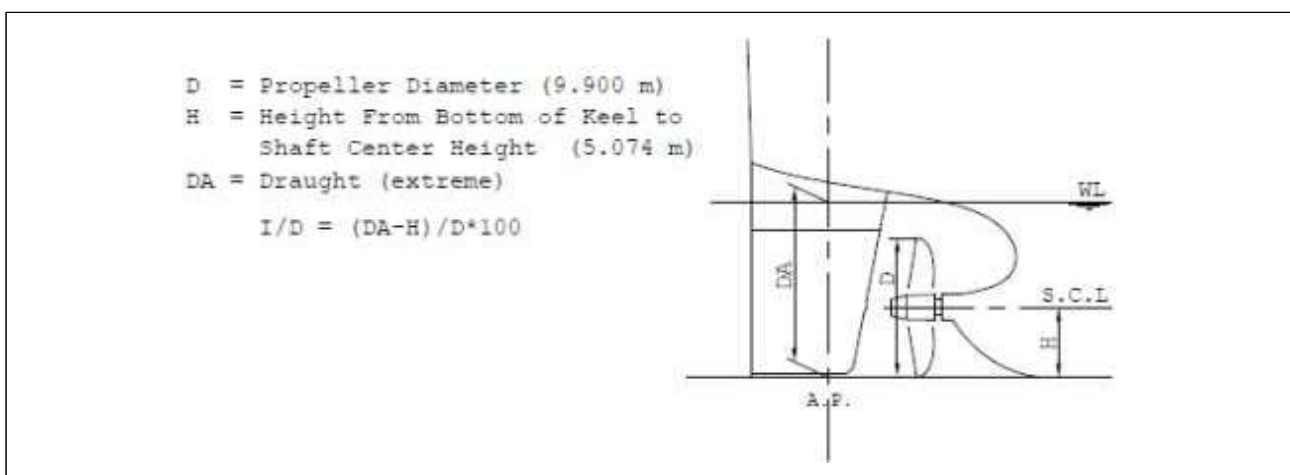
<Figure 26> Calculation for the propeller immersion ratio of *Milano Bridge*

4.3.4 A more specific calculation of the immersion ratio is illustrated in Figure 26, based on which the I/D value is calculated to be 18.4.<sup>30)</sup> It means the immersion ratio of *Milano Bridge* is estimated only at 68.4% (50+18.4) at the time of the accident.

30) If putting the values into the equation,  $I/D = (DA-H) / D \times 100$ , the calculation is as follows:  $I/D = (6.9-5.074) / 9.9 \times 100 = 18.4$ . The sea trials were conducted in ballast with I/D of 55.1% (draft aft: 10.53m, draft forward: 4.67m) after *Milano Bridge* had been built.

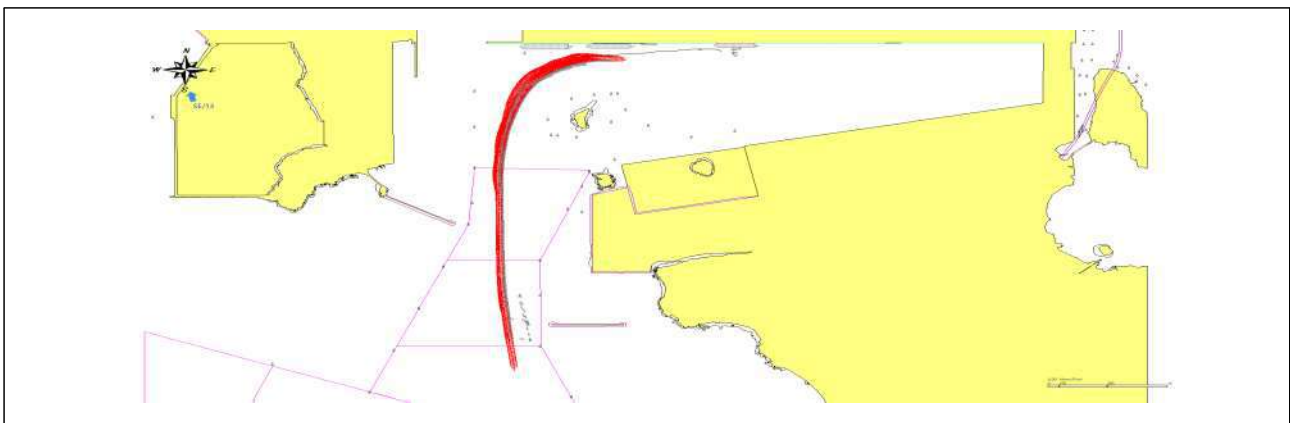
<Figure 33> Track of the simulation

- This simulation was applied with the same rudder and engine orders, as recorded in the VDR, under the same weather conditions (wind and waves) and draft levels as during the accident. Also, the causal factors, which weakened the propulsion forces and rudder effectiveness of *Milano Bridge* due to her propeller exposure, were reflected in the simulation. The result represented a vessel track almost identical to the one during the accident<sup>37)</sup> (a solid line marked in the figure above).
- While reproducing the trial performance in ballast and the actual track during the accident, ship maneuverability was proven to have been significantly degraded compared with the trial performance after shipbuilding, as the propeller's propulsive efficiency had been weakened due to its excessive exposure.

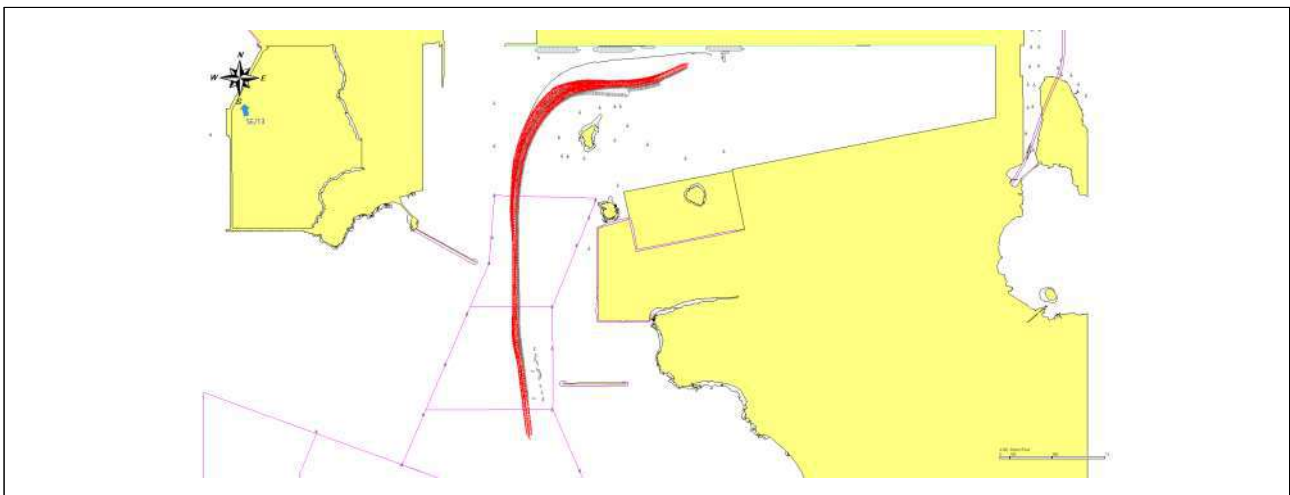
<Figure 34> Track of the simulation

- Under the same conditions as in Case 1, only the draft was changed, setting the vessel in full ballast where the propeller was 100% immersed. The same rudder and engine orders were used just as recorded in the VDR, while no decrease was made in propulsion forces and rudder effectiveness. As a result, the vessel turned out to be able to secure a safe distance from the pier as her tactical diameter was smaller than that it had been during the accident.

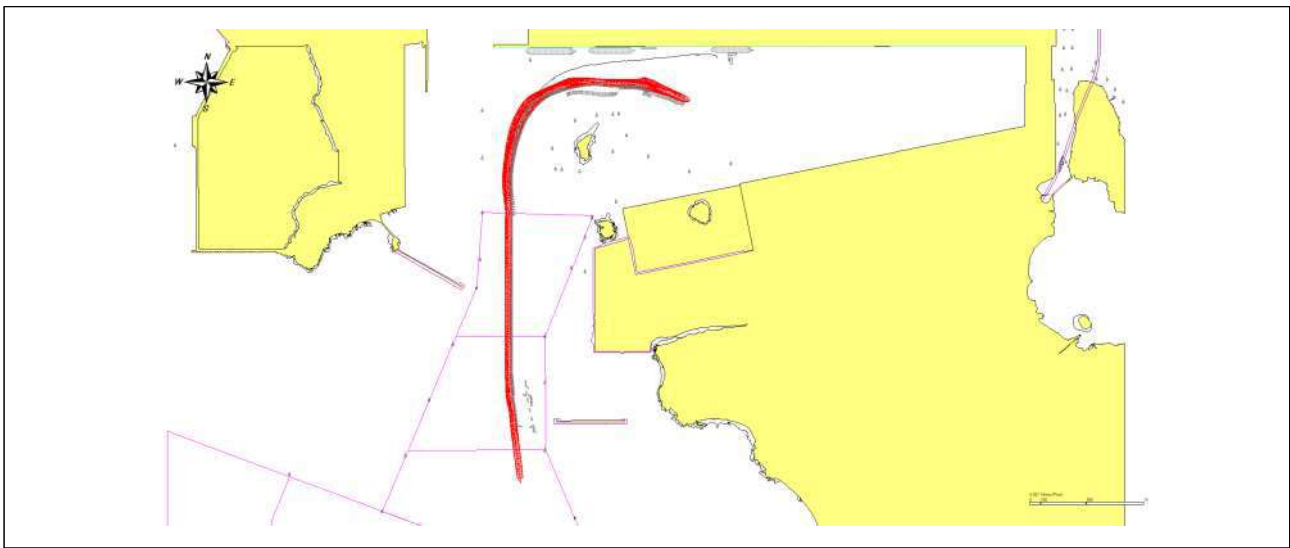
<Figure 35> Track of the simulation

- In this simulation, the wind factor was removed under the same conditions as in Case 1 (wind speed, reduced from 13 knots to 0). As a result, the track in this simulation presented the vessel getting farther away from Pier No.3, at a distance of 100-150m, two or three times the beam, compared with the track during the accident. In general, a vessel is more affected by external forces, such as wind or current, if she reduces her speed so that she can maintain her maneuverability to the minimum level required for berthing. The result from this simulation was not much different from the facts above.
