## Investigation Report 149/08

**Serious marine casualty**

**Forward tug WILHELMINE  
broaching to in front of  
MV PAVEL KORCHAGIN  
on 4 April 2008  
in the Port of Hamburg**

15 April 2009

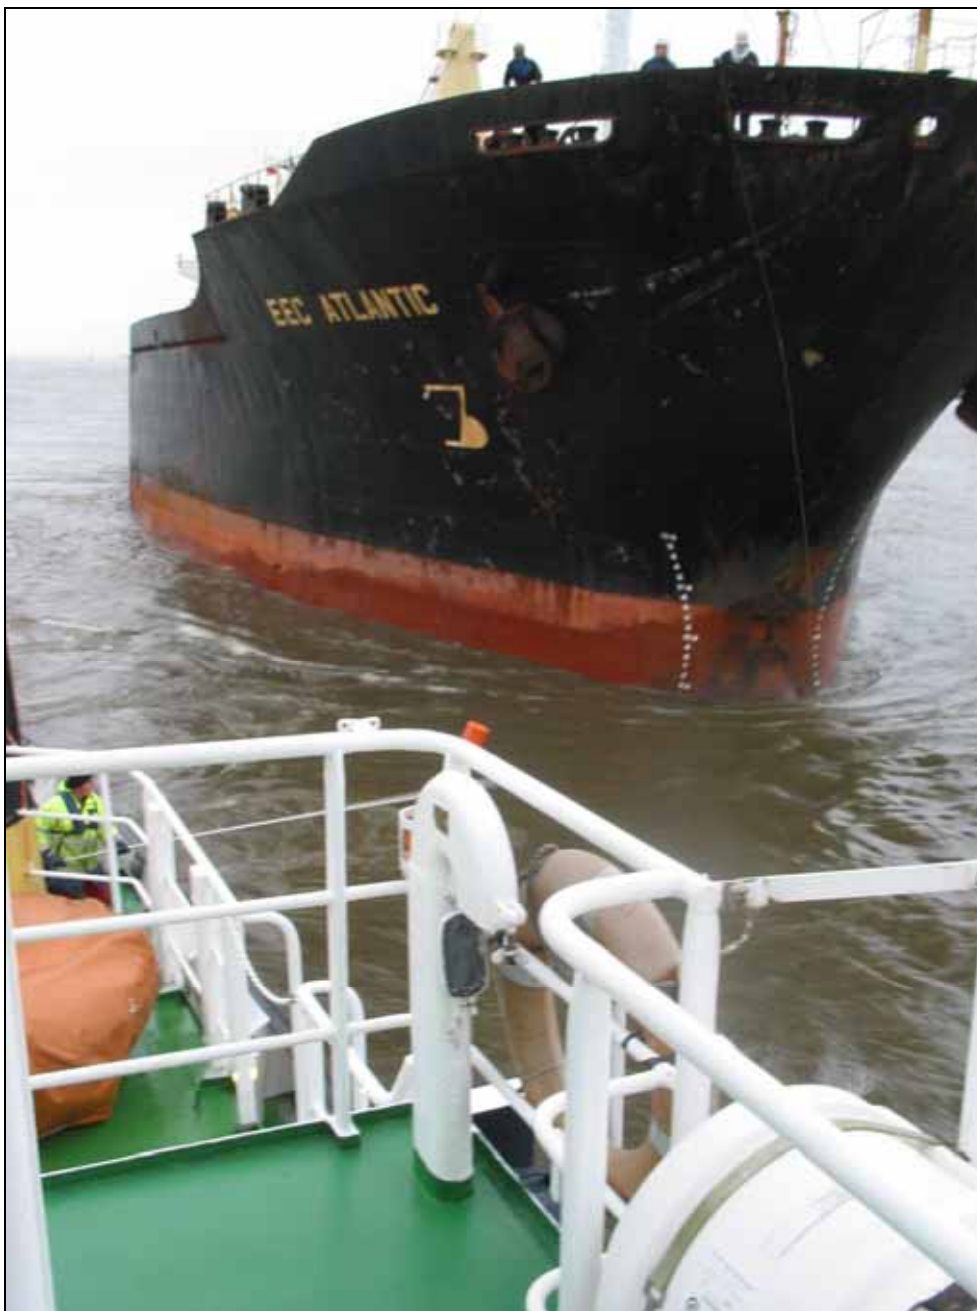
Figure 11: Take-up of heaving line

The master navigated by sight, crossed the fairway off Blankenese and turned in, approaching the front of the ship on her starboard side, coming from astern. When attempting to catch the ship's heaving line, the tug was inevitably forced to operate in the bow-wave zone. On the first attempt, the heaving line fell into the water (see Fig. 11). At a speed over ground of 8 kn, it was possible in the end to catch the heaving line in front of the bow and secure the tripping line. Once the tripping line had been made fast through the central hawse on the ship's forecastle, the hawser could be fastened. For this, the winch was operated by the engineer on the after edge of the bridge. While pulling the line in tightly, the deckhand determined that the shackle on the forerunner was loose. The hawser had to be slackened so that the bolt pin could be tightened with a shackle key. Then approx. 40 m of line were fed out. The procedure took approx. 5 min.

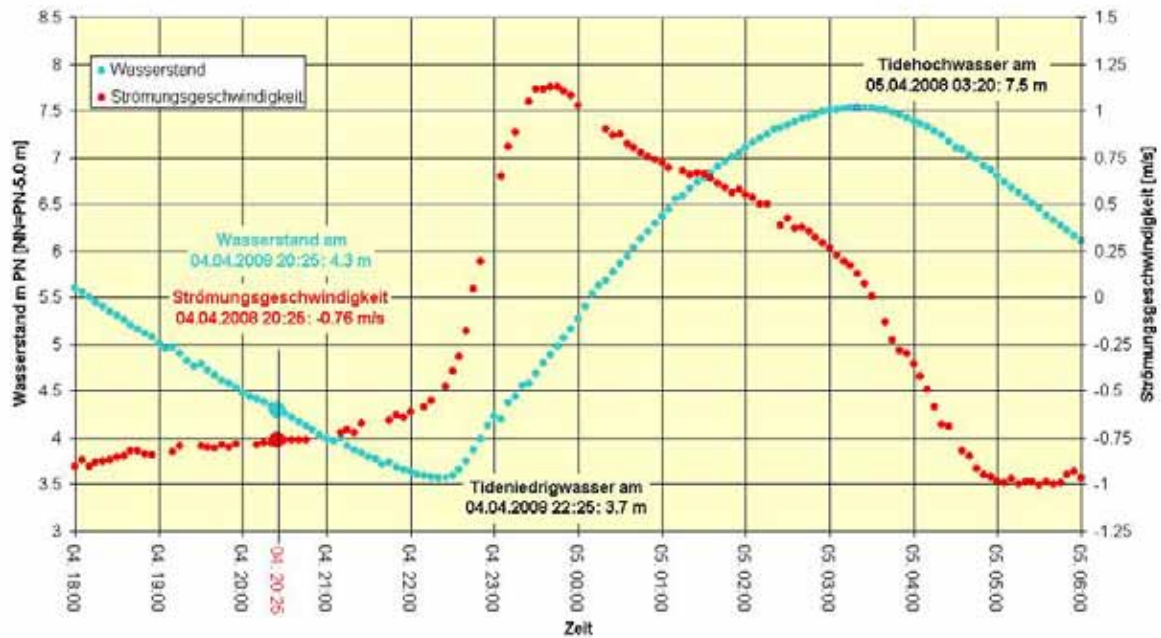
2

**Figure 2** gives the water level and the flow rate of the current measurement system at Teufelsbrück for 04.04.08, and the time 20:25 is also specifically pinpointed. The prevailing flow rate was 0.76 m/s in a westerly direction (ebb current). Low tide occurred at 22:25, two hours after the time under consideration.

**Flow rate at the Teufelsbrück measuring station  
from 04.04.08 to 05.04.08**

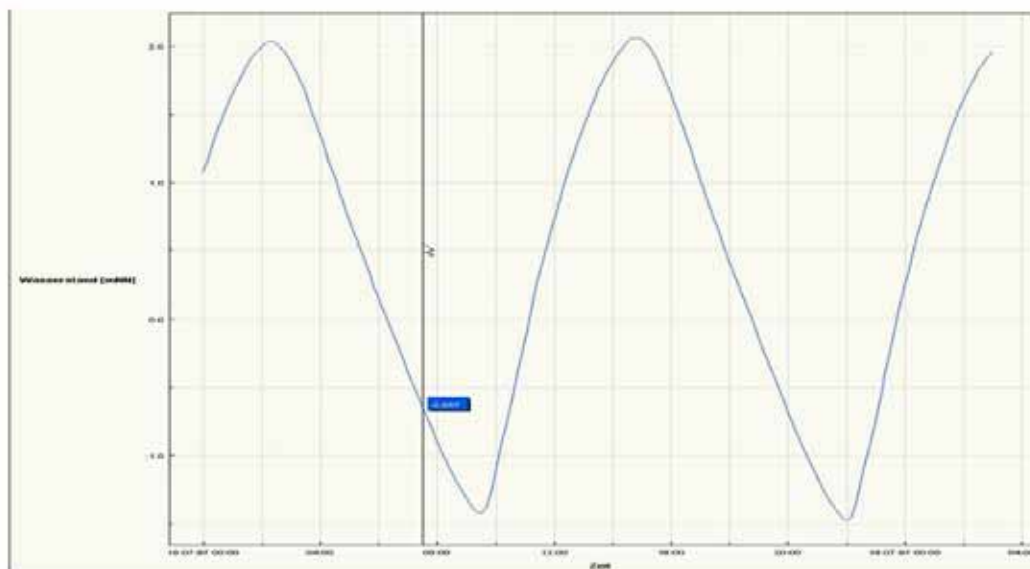
3

**Figure 3** shows the transfer of tide times on 04.04.08 to the model based on the water level. Two hours before low tide corresponds to a model time of 07:25.

**Water level at Teufelsbrück, two hours before low tide**

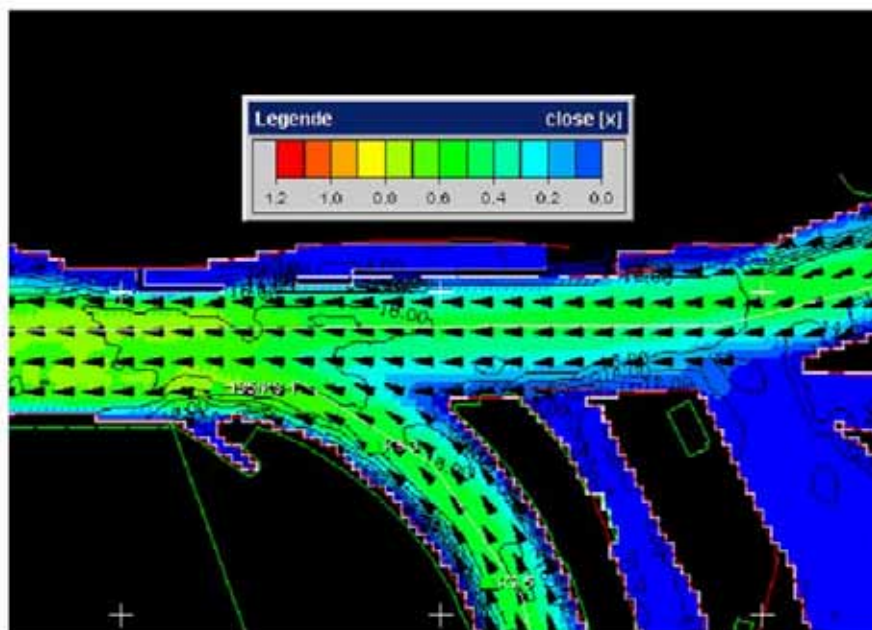
6

**Figure 6** shows this rate again in the relevant expanse, revealing that, from the centre of the water to the edge, the rate decreases.

Model result: flow rate end direction of flow at Tollernort two hours before low tide (averaged across depth)
