[MSI Report 2021-001]

# Marine Safety Investigation Report on *M/V MILANO BRIDGE* - Contact with gantry cranes -

Date of Accident: 6 April 2020

Korea Maritime Safety Tribunal  
Marine Safety Investigation Team

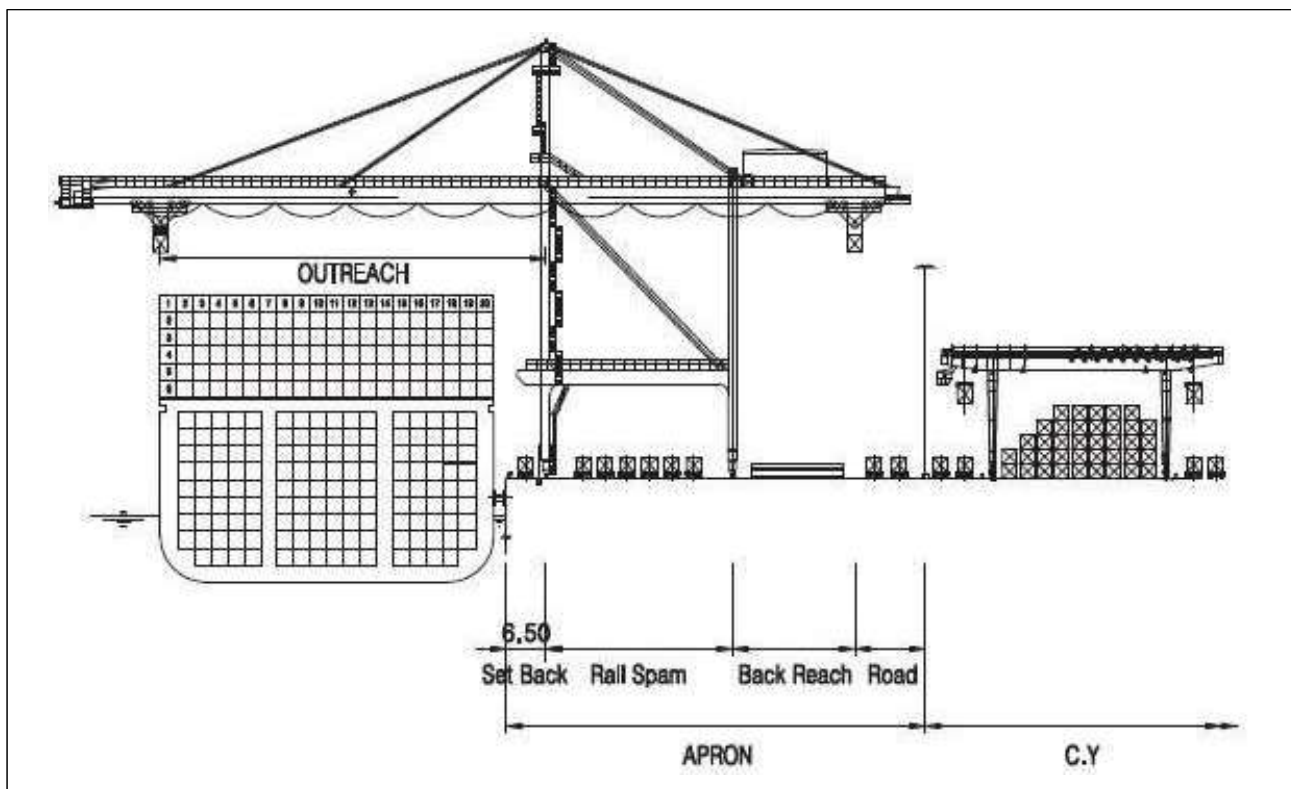
<Figure 9> Apron of Pier No.2

2.9.3.2 As prescribed in Article 4.3.2 Container Terminal Design Code of the Design Standard for Ports and Fishery Harbors (KDS 64 60 10), aprons shall be designed so that containers can be temporarily laid, or that loading equipment such as cranes and vehicles can be easily operated. In general, setbacks are designed to be 3.5 to 6.5 meters, depending on the characteristics of the bollards, gantry crane cable trays, and terminals. In the case of Pier No.2 at Busan New Port, the setback was about 6.5 meters.

2.9.3.3 The depth of *Milano Bridge* is 29.9 meters. When the accident occurred, her aft draft was 6.9 meters, meaning that the part of the vessel above the waterline to the upper deck was about 23 meters high. Moreover, the quay wall was about 3.5 meters above the waterline at the time the ship was berthing at the pier. At Pier No.2, therefore, the height from the top side of the quay wall where the gantry crane was located to the upper deck of the vessel was about 19.5 meters.

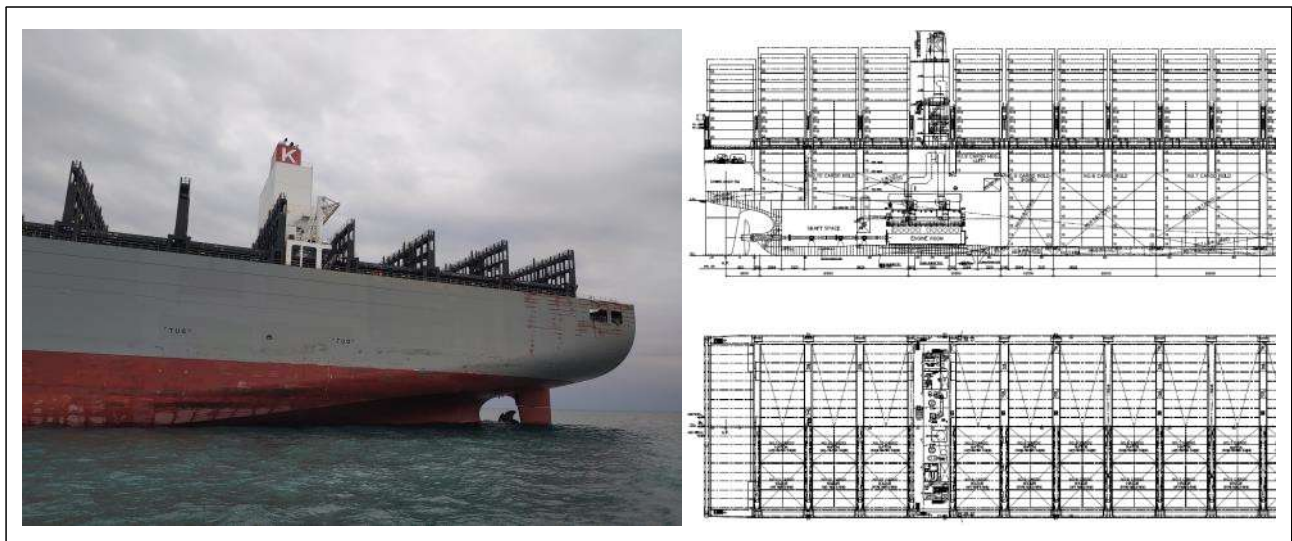
<Figure 10> Aft body of *Milano Bridge*

2.9.3.4 Containerships have a flared bow and stern. As *Milano Bridge* also has a flared stern, the deck areas of cargo hold Nos.8 to 10 at the stern are like those midships. But, the area narrows sharply at the lower part near the propeller and rudder.

2.9.3.5 If a containership approaches the quay wall at a large angle with her upper part significantly exposed above the waterline due to a low draft, the upper part is likely to cross over the quay line. *Milano Bridge*, too, given both the aft draft and water depth of the quay wall at the time of the accident, was likely to have had the upper part of the side shell of her stern enter further into the quay without contacting the wall, depending on the berthing angle. And, in that case, avoiding contact with a gantry crane would have been particularly difficult while turning to starboard just ahead of the pier.

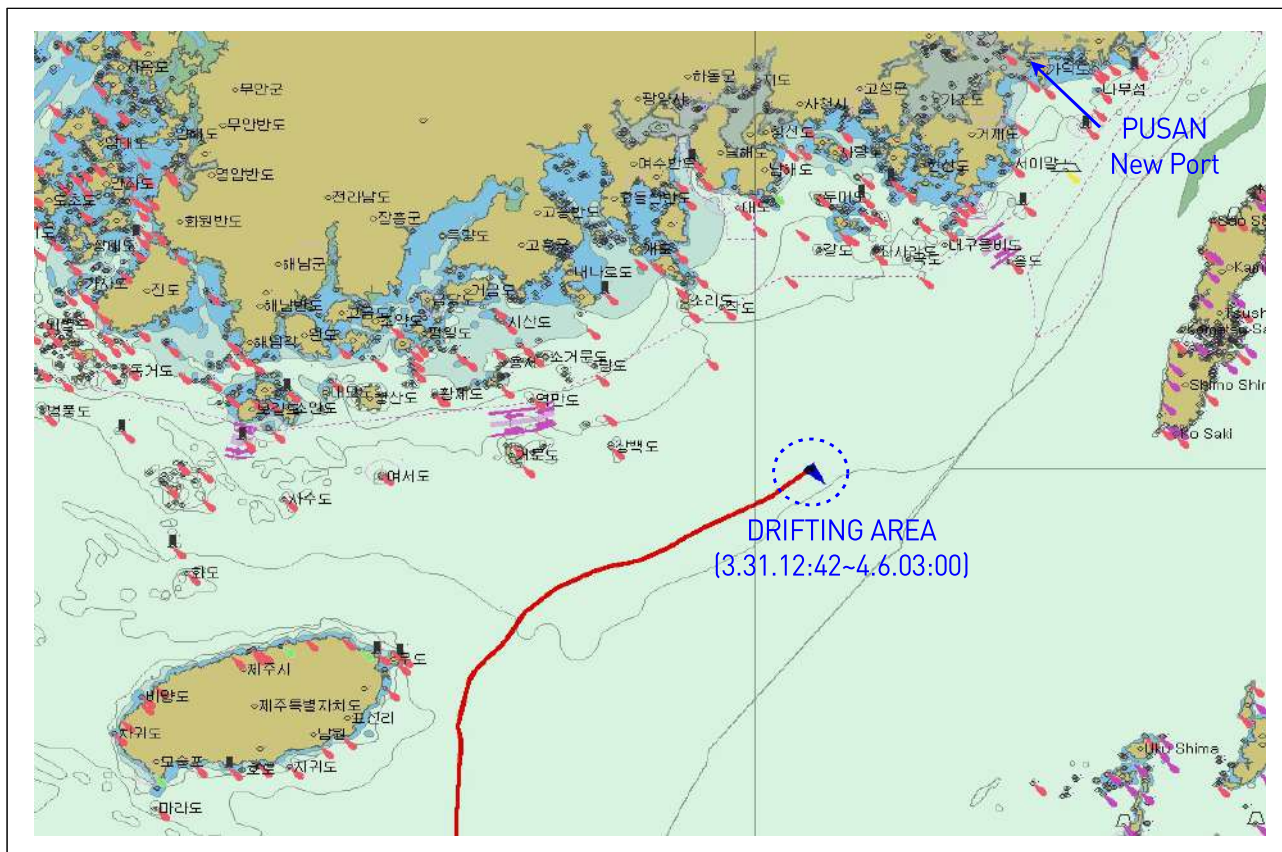
<Figure 18> Drifting area before arriving at Busan New Port (AIS track)

3.1.8 Therefore, the vessel took on total 4,223 tons of ballast water in W.B.Tanks No.2, No.4, and No.6 on both sides, which made the draft aft and forward to 6.9 and 4.5 meters, respectively.

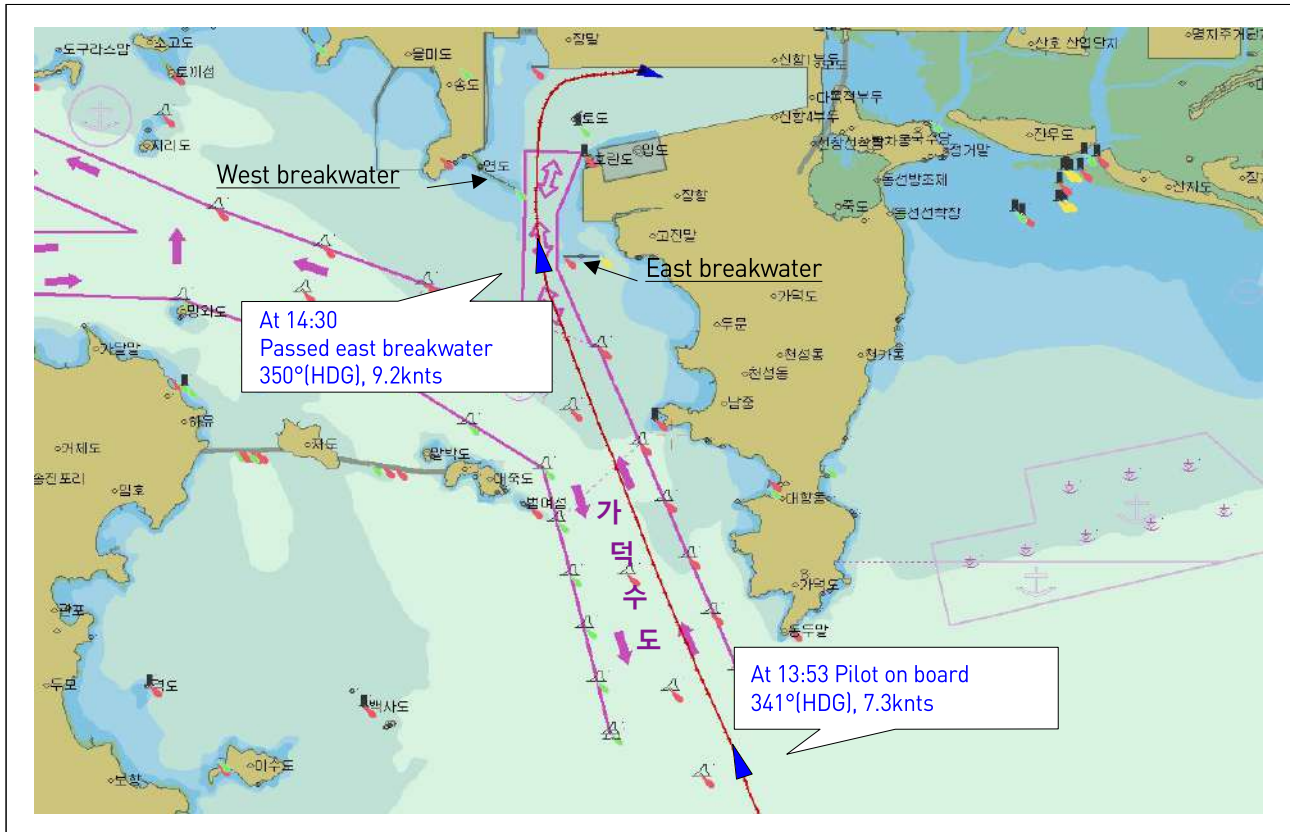
<Figure 19> Port entry track at Busan New Port (AIS track)

- 3.3.1 On 6 April 2020, *Milano Bridge* approached the right side of Gadeok Channel at around 14:00. While reporting the port entry of the vessel to the VTS of Busan New Port, Pilot A said that the vessel would “enter the waterway between the Hanjin Terminal (Pier No.3) and To Islet,” and the VTS responded by saying, “understood.”
- 3.3.2 After entering Gadeok Channel, the vessel proceeded about 4.5 miles on a course of 338° with the main engine running half ahead at 30 rpm and at a speed of 9 knots (referring to SOG, hereinafter the same applies), to the east breakwater of Busan New Port.
- 3.3.3 As *Milano Bridge* sailed along the channel, no other vessels were on her route except a general cargo ship (M/V *Qing Ping*), which departed from the multi-purpose pier of Busan New Port. On the same day, *Milano Bridge* met with M/V *Qing Ping* in the

- 3.3.4 On the same day, the vessel arrived at the waters 0.5 miles south from the westernmost side of the east breakwater of Busan New Port at around 14:27. Then, Pilot A ordered the course be altered to 355° while keeping the main engine running half ahead. As the vessel passed the east breakwater on her starboard beam at about 9.2 knots around 14:30, he asked the master to take the tow lines of the aft tug on the starboard quarter.
- 3.3.5 When *Milano Bridge* was about to pass the east breakwater around 14:31, Pilot A ordered the course altered to 000° while keeping the main engine revolutions and speed the same. On the same day, the tow line of the aft tug, M/V *Seonjin 100*, was secured on the starboard quarter of *Milano Bridge* at around 14:33 while that of the forward tug, M/V *Hankook 51*, on the starboard bow was not.

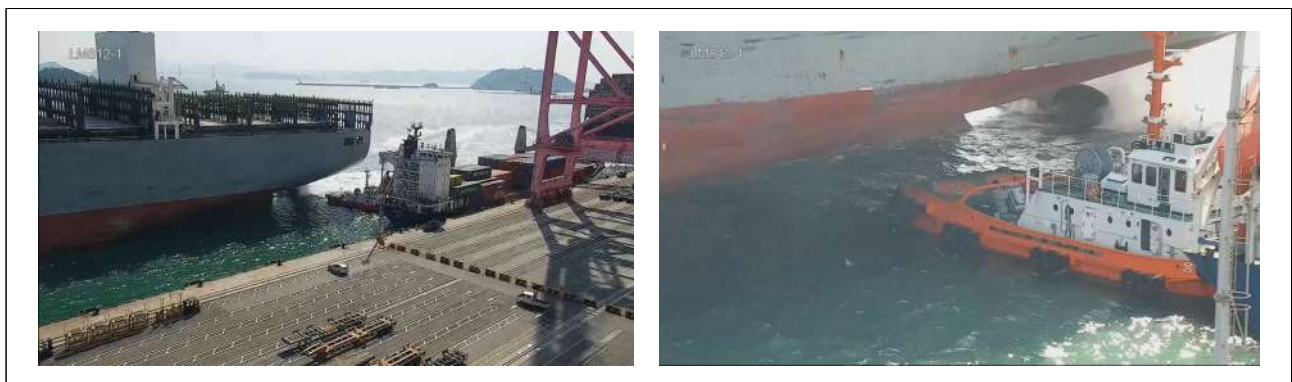
<Figure 21> Space between *Milano Bridge* and M/V *Proteus* (CCTV)

- 3.5.2 At around 14:47, Pilot A ordered the aft tug to stop pulling and the rudder hard to starboard as the heading became about 087°. He then issued a series of urgent steering orders, including hard to port and hard to starboard to turn the vessel to starboard while preventing the stern from drifting toward the pier. At that time, the speed of *Milano Bridge* was about 6.2 knots, and her stern moved to within ten meters of M/V *Proteus*, a containership standing by for departure at Berth No.1 of Pier No.3.

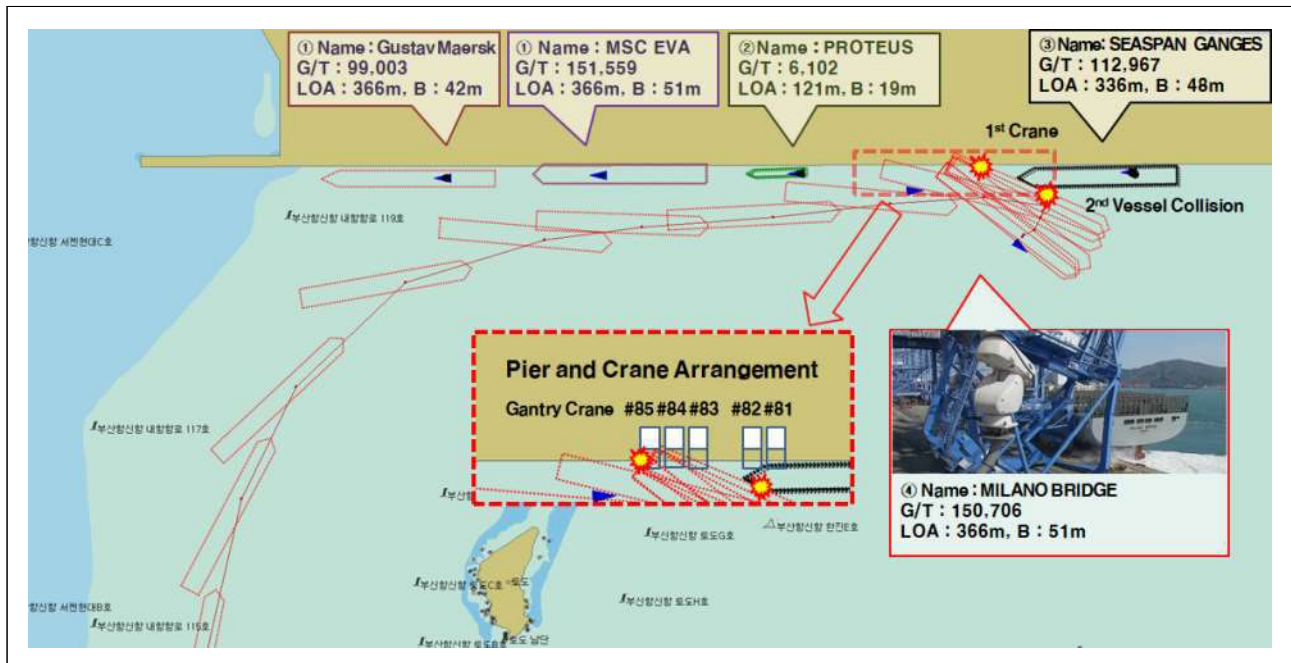
<Figure 22> Berthing arrangement and collision when the accident occurred

- 3.5.3 At around 14:38, with the bow turning to starboard, *Milano Bridge* barely passed M/V *Proteus*. However, at around 14:49, when *Milano Bridge* was on a heading of 104° at about 5.6 knots, the port bow of the vessel contacted Gantry Cranes No.84 and No.83 in succession, after a crash into a Gantry Crane No.85 at Berth No.8 of Pier No.2. As for Gantry Crane No.81, its boom, a horizontally lowered beam, made a hard contact

with the port wing bridge of *Milano Bridge*, cutting the support frame of the crane and collapsing its lower part.

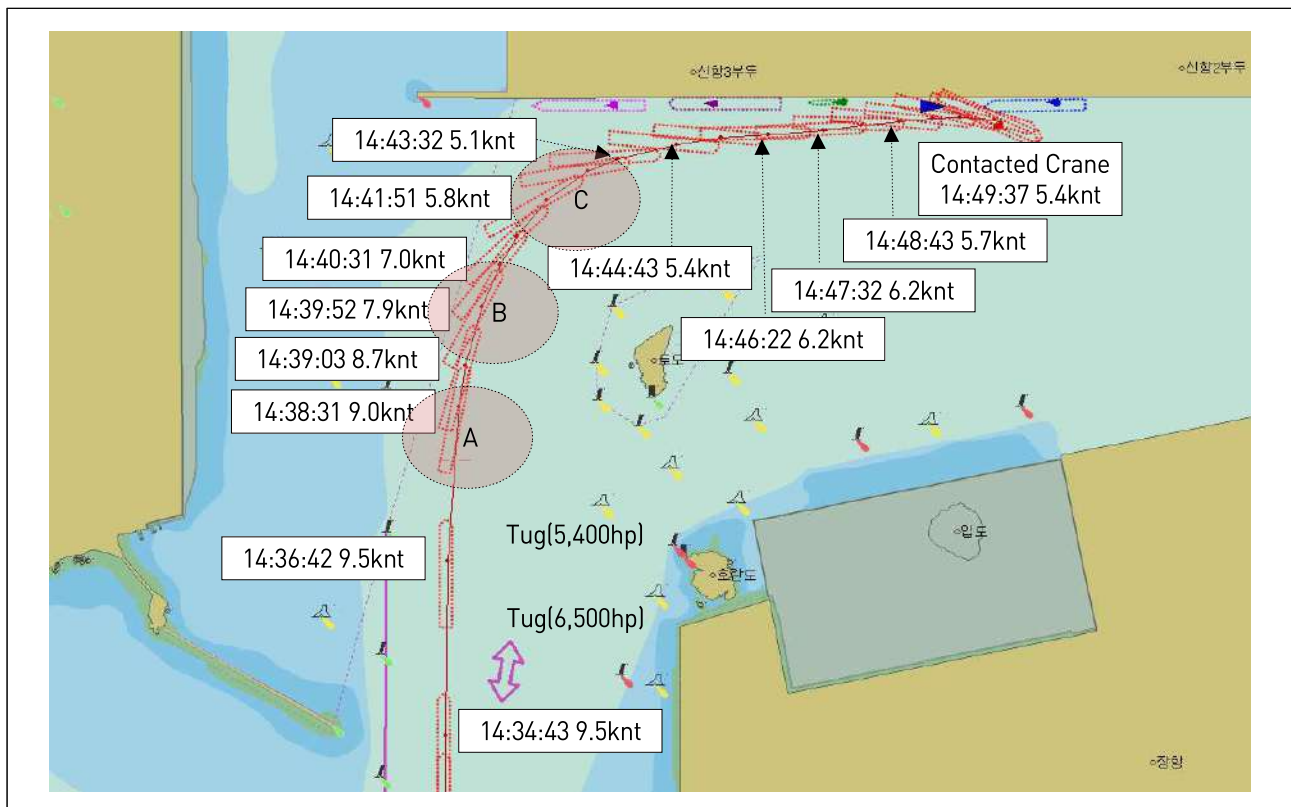
<Figure 27> Track of *Milano Bridge* at the time of the accident

4.4.1.2 Around 14:36, Pilot A first ordered starboard 10° to turn the vessel to make a 90° change in heading to starboard and proceeded to the waters off Pier No.2 at the position with a straight-line distance of 0.84 miles (1,556 meters) from the quay of the North Container Terminal before arriving Point A, marked in Figure 27.

4.4.1.3 At around 14:39, Pilot A ordered the main engine stopped to lower the speed when passing Point B. He, however, feeling that the vessel turned much slower than expected due to a low rate of turn, sought to increase the rate of turn further by ordering hard to starboard and setting the main engine to dead slow ahead. Also, at around 14:40, the pilot ordered the aft tug on the starboard quarter to push the stern and the bow thruster full to starboard to increase her turning rate to starboard.

- 4.4.1.4 Despite this, the starboard turn was further delayed while the vessel proceeded even closer to the pier. Thus, Pilot A, who was worried that the vessel might collide with the other vessels berthed at Pier 3, at around 14:41 ordered to increase the turning rate at Point C so that the speed can increase and he can avoid collision.

- 4.4.1.5 At around 14:43, *Milano Bridge* passed Point C and made a large course change of 90°, approaching within 100 meters from the vessel berthed at Pier No.3 (150 meters from the quay). She proceeded further, reached dangerously close to the vessel, almost hitting her, and then turned to starboard. The recorded track shows that while being turned, her port stern struck a gantry crane at the berthing pier and then collided with the berthed ship, M/V *Seaspan Ganges*.

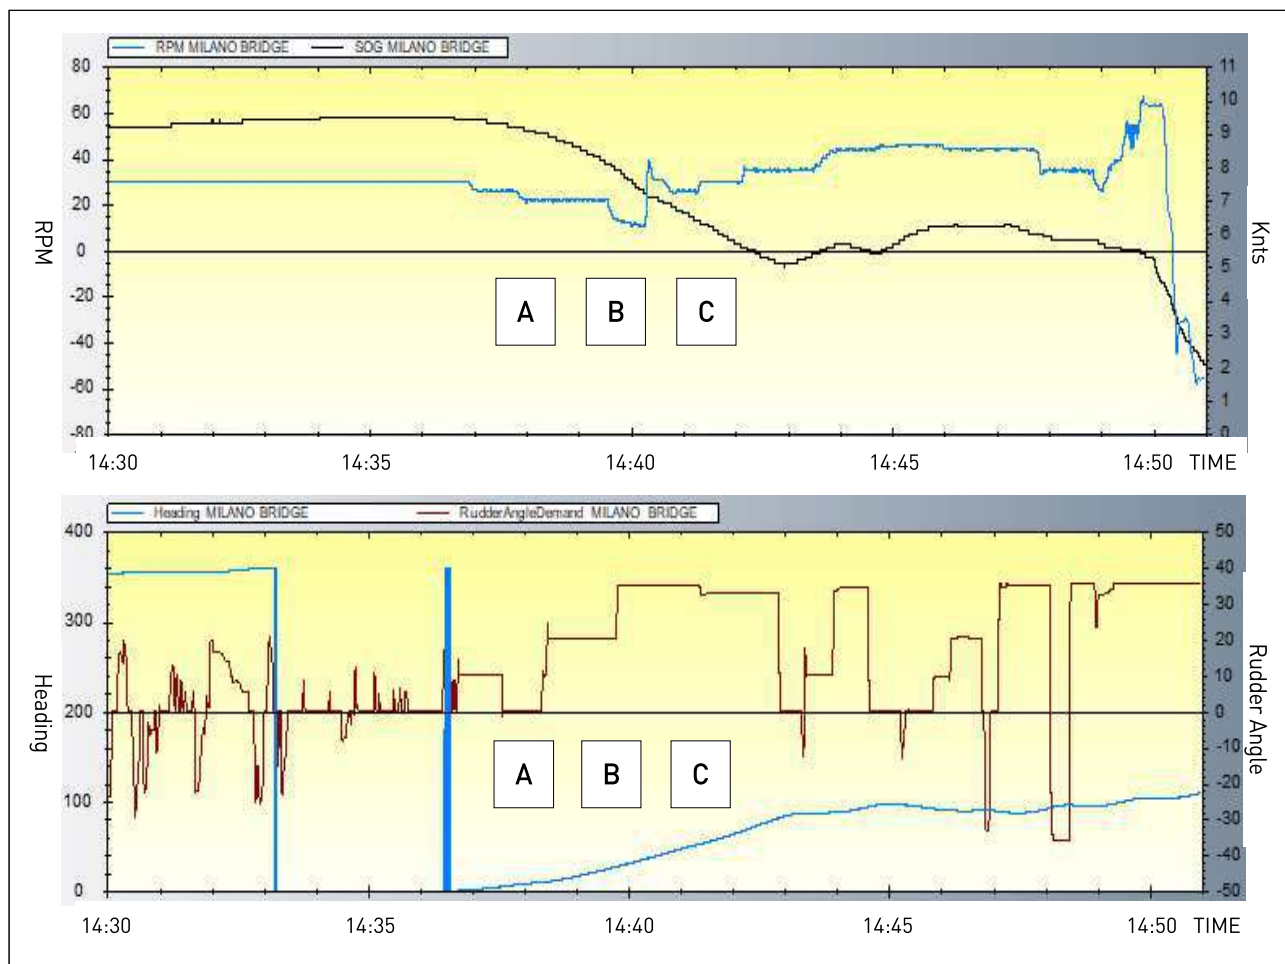
<Figure 28> VDR Record

- 4.4.1.6 Figure 28 illustrates rpm, vessel speeds, headings, and change of rudder angle, recorded in the VDR from around 14:30 right before *Milano Bridge* approached the west breakwater of Busan New Port to around 14:50 when the collisions took place.

4.4.1.7 The vessel put To Islet on the starboard side and made a large course change of 90° to turn starboard from 14:36 to 14:43 (approximately 7 minutes and 45 seconds on a per second basis). In the following table, such a track (from Point A to C) was compared with the track of *Milano Bridge* during the sea trials,<sup>34)</sup> when she was in ballast at half ahead (10.6 knots), like the conditions at the time of the accident.

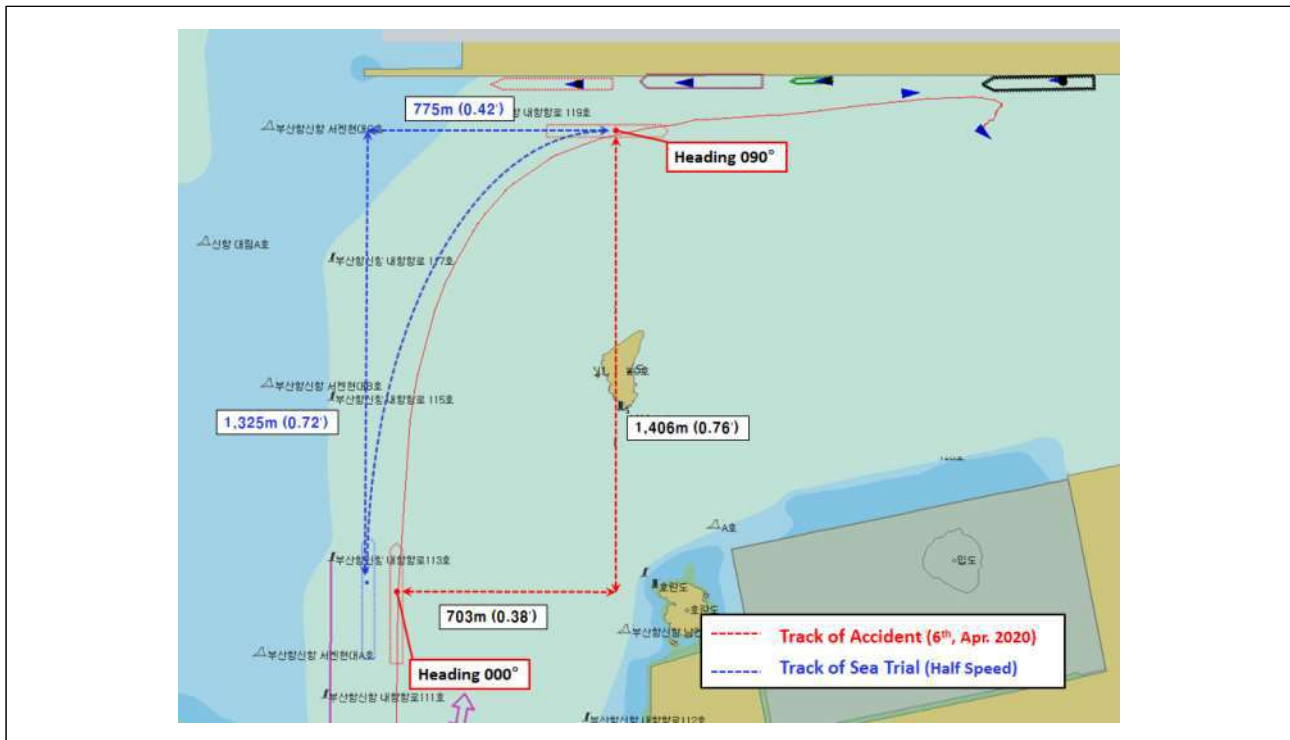
<Figure 29> Track comparison

- Compared with the performance during the sea trials in ballast at half ahead, it took 1 minute and 40 seconds longer to make a 90° change of heading from its initial path of heading by turning to starboard. The advance was 81 meters longer while the transfer was 72 meters shorter than that of the sea trials. (See Table 9)
- In the initial turning, as the vessel turned slowly, her advance was increased due to forward momentum. However, in the latter half of her turning, the vessel veered starboard relatively fast as she used tugs, presumed to reduce the transfer.
- It turned out that the reduction in rudder force (lower turning moment) from the low propulsive efficiency of the propeller was significant in delaying the initial turning of the vessel.

<sup>34)</sup>It is not appropriate to simply compare the actual track of *Milano Bridge* during the accident, where she turned while adjusting main engine speed variously, to the track during the sea trials, where she turned with the engine half ahead and rudder angles of starboard 35°. Still, the latter was used as a comparing value in order to give a simple explanation on the vessel track during the accident.

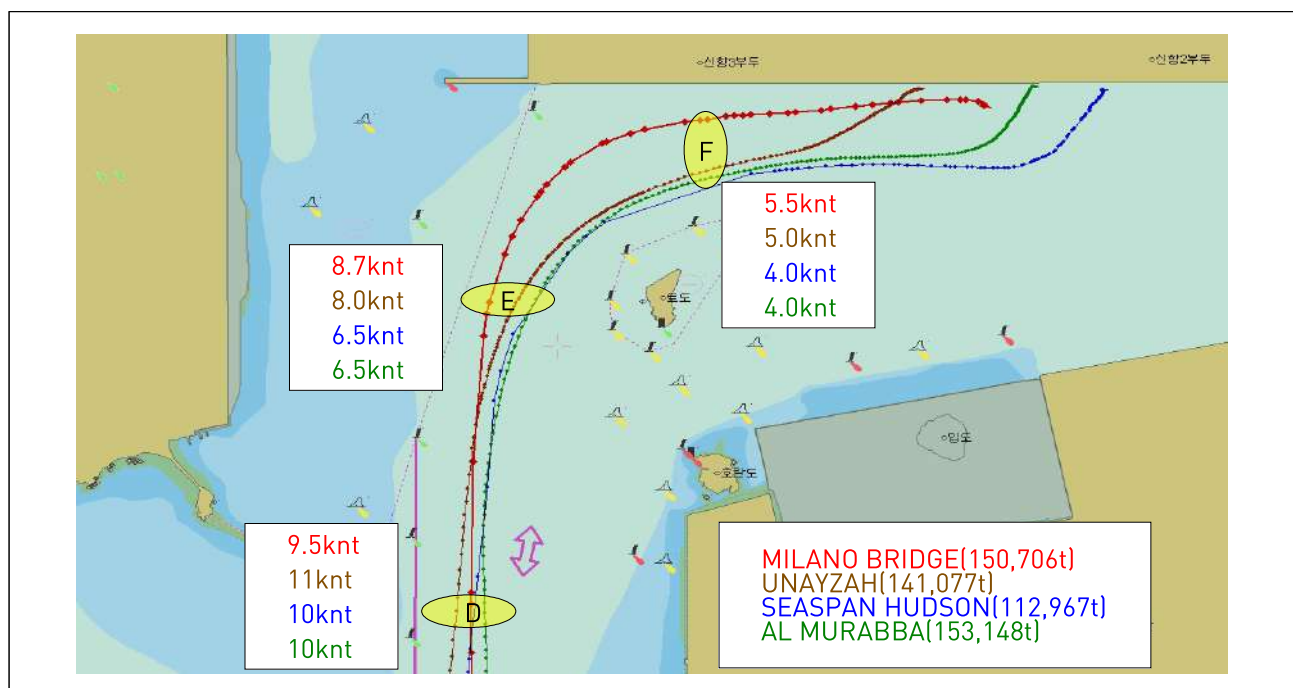
<Figure 30> Tracks of vessels at the time of the accident

4.4.2.1 Pilot A had piloted four vessels in total (including *Milano Bridge*) into berthing at Pier No.2, putting To Islet on starboard side, among vessels over 100,000 tons that had entered Busan New Port since 2019 until the day of the accident. Figure 30 illustrates their tracks.

4.4.2.2 *Milano Bridge* proceeded into the port 0.8 knots slower than the other three vessels' average speed of 10.3 knots at Point D, passing the west breakwater of Busan New Port. At Point E, passing To Islet, however, Pilot A started to turn *Milano Bridge* at speed 0.7 to 2.2 knots faster than the other vessels he had piloted. Her speed at Point F in front of Pier No.3 remained 0.5 to 1.5 knots faster than that of the other vessels as the speed of *Milano Bridge* was slowly reduced.

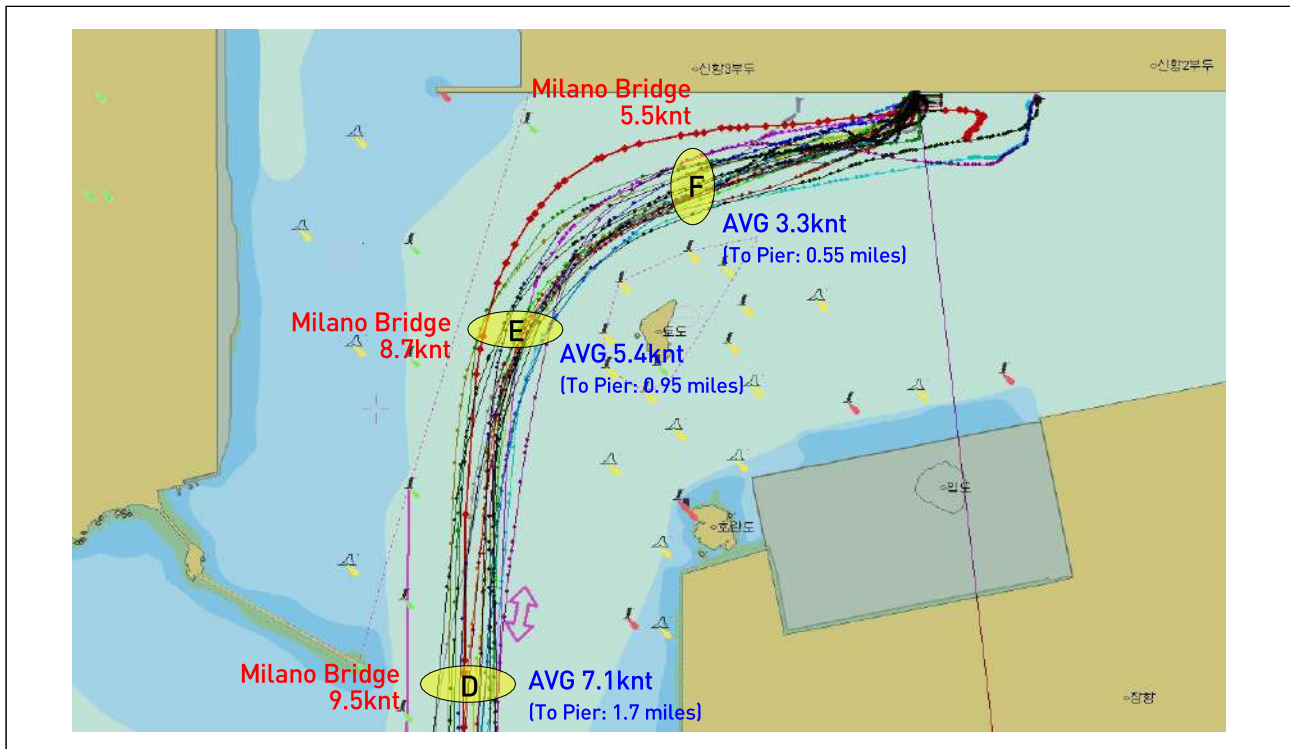
<Figure 31> Berthing tracks of 23 vessels

4.4.3.1 Among the large vessels (over 140,000 tons) that had entered Busan New Port from January to April 2020, a total of 23 had berthed at Piers No.2 or 3, putting To Islet on the starboard. Figure 31 compares the tracks of these vessels with that of *Milano Bridge* during the accident.

- 4.4.3.2 Figure 31 shows that *Milano Bridge* was at 9.5 knots, 2.4 knots faster than the other vessels, whose average speed was 7.1 knots at Point D, passing the west breakwater. Even at Point E, passing To Islet, *Milano Bridge* was at 8.7 knots, 3.3 knots faster than the other vessels' average speed of 5.4 knots.

- 4.4.3.4 A simple comparison would be difficult as operation conditions at the time, such as weather, vessel drafts, or maneuverability, varied. However, when comparing the process of *Milano Bridge* passing the islet and making a large course change, with those of the other 23 vessels, it turns out that *Milano Bridge* approached at a

relatively fast speed, made a late turn, and increased the tactical diameter.

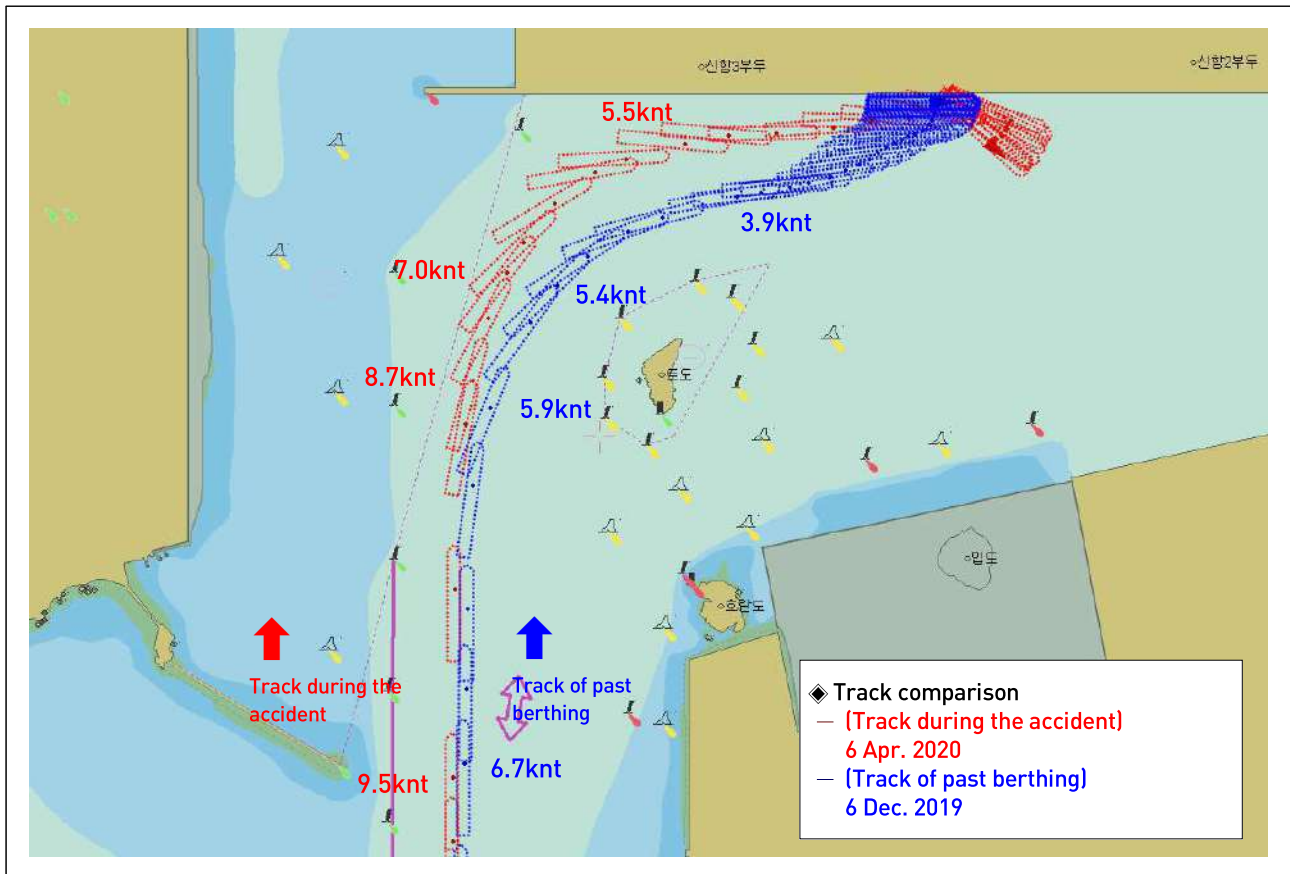
<Figure 32> Comparison between the past track of *Milano Bridge* and the track during the accident

4.4.3.5 Figure 32 compares the track of *Milano Bridge* being normally berthed at Pier No.2 of Busan New Port by a different pilot on 6 December 2019 with the track of this accident on 6 April 2020.

4.4.3.6 The track of *Milano Bridge* on 6 December 2019 when berthing at Busan New Port was like the average track of the other large vessels illustrated in Figure 32. Operating conditions, such as maneuverability or weather, in addition to the draft of 12.7 meters at the time, meaning that her propeller was fully immersed, were different from the conditions during the accident. Still, speeds at the points passing the west breakwater and To Islet at the time were relatively faster than those in the past track and reduced slowly, which increased the tactical diameter according to the analysis.

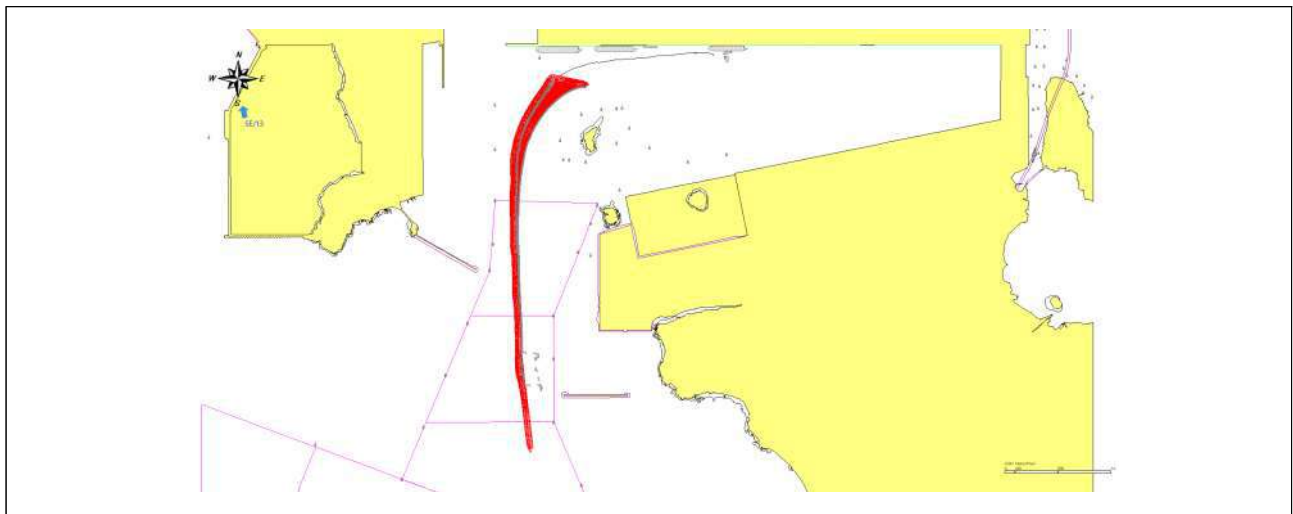
<Figure 36> Track of the simulation

- In this simulation, when passing To Islet, the vessel reduced her speed to about 5 knots and made a turn to starboard as recorded in the VDR under the same weather and draft conditions as in Case 1. As a result, the vessel made a 90° change in heading at the mid-point between the quay and the islet.
- That means if *Milano Bridge* had reduced her speed to about 5 knots while passing the islet, she is presumed to have secured a safe distance from the quay as the vessel would make a 90° change in heading at the mid-point between the quay and the islet, just as the track of the other similar vessels described in Paragraph 4.4.3.
